## Transportation Category

# Sunshine Skyway Bridge Trestle Span Repairs

Tampa Bay, Florida

Submitted by Sika Corporation

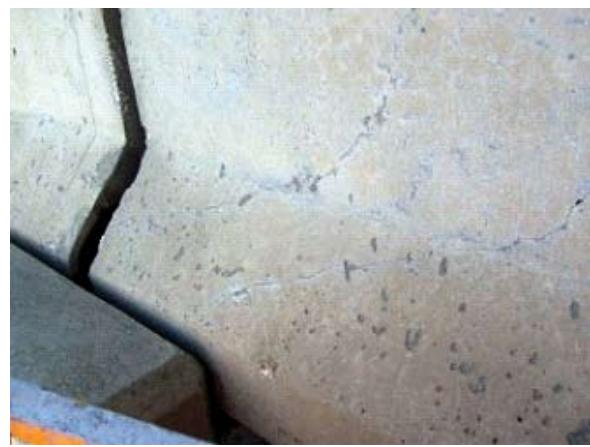
Shear cracking was observed during routine inspections of the trestle span girders. Inclined shear cracking was much more prevalent in the exterior girders than the interior girders. In addition to the deficient AASHTO girders, cracks were observed in

Close examination and comparison of the as-built plans to the final design plans revealed significant deviations. These deviations had an impact on both the flexural and shear capacity of the girders. One of the conclusions was that the reduction in shear capacity was due to the excessive strand debonding at the ends of the girders. Because the beams were designed to remain uncracked under full design service loads, the observed cracking presented a serviceability problem. The opening and closing of these cracks under applied loads would create a durability issue. Situations where the cracks extended into both faces of the web were considered critical due to the transfer of the shear force from the concrete to the steel. A repair was critical to guard against fatigue of the existing reinforcement.

*Typical shear cracks*

To first address the shear cracks present in the AASHTO girders and the pile caps, a specification was written to epoxy-inject all cracks having a width exceeding 0.012 in. (0.3 mm). All spalls were patched using a cementitious repair mortar in compliance with ICRI guidelines. All uneven surfaces were filled in with a leveling mortar and all bug holes and smaller cavities were repaired using an epoxy paste. In addition, a clear protective sealer was applied to protect the concrete from further moisture and chloride intrusion.

To restore the shear deficiencies at the end of the AASHTO girders, a bidirectional carbon fiber fabric was used to wrap the members. The carbon fiber was applied in a special sequence and orientation to achieve the strength necessary to reinforce the girders and meet the design live load requirement of HS 20-24 per FDOT specifications. First, a 24 in. (610 mm) wide strip was placed vertically down the girder, around the bottom, and up the other side to create a U-wrap similar to a stirrup. Next, a strip was wrapped around the bottom bulb of the girder to strengthen the flange. Finally, another strip was placed longitudinally along the top flange adjacent to the soffit of the bridge deck. The reason for using a bidirectional fabric was to achieve supplemental loading in multiple directions without having to install additional plies.

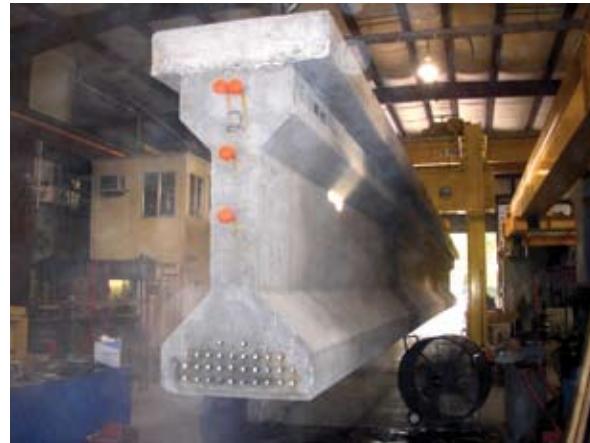
The Sunshine Skyway Bridge comprises the main span, the high-level approach, and the low-level trestle spans. A total of 650 precast concrete girders support the northbound trestle spans and another 650 girders support the southbound span. American Association of State Highway and Transportation Officials (AASHTO) Type IV girders were used for a majority of the 100 ft (30 m) long trestle spans.

*AASHTO Type IV girders*

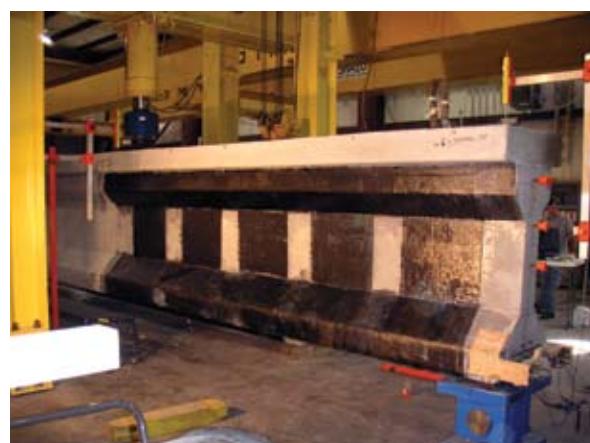
Prior to the start of construction, load testing was performed on full-scale AASHTO Type IV precast girders in the Florida Department of Transportation (FDOT) Structures Lab in Tallahassee. This testing was done on four different test setups to simulate

the loads on the bridge and the various strengthening configurations. In one scenario where the load was applied at a 15 ft (4.6 m) offset, the carbon fiber-reinforced polymer (CFRP) strengthened beam achieved an increase in shear capacity of 21%. In the other scenario where the load was applied at a 7.2 in. (2.2 m) offset, the CFRP strengthened beam achieved an increase in shear capacity of 10%. This testing confirmed the engineer's calculations that a CFRP upgrade would be the best solution for repairing the shear deficiency in the AASHTO girders.

*Load testing of AASHTO girders in lab*

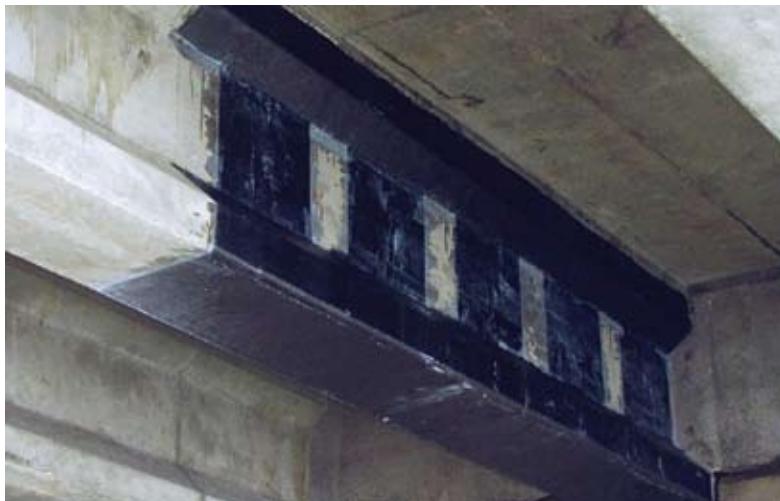
*CFRP layout on AASHTO girders*

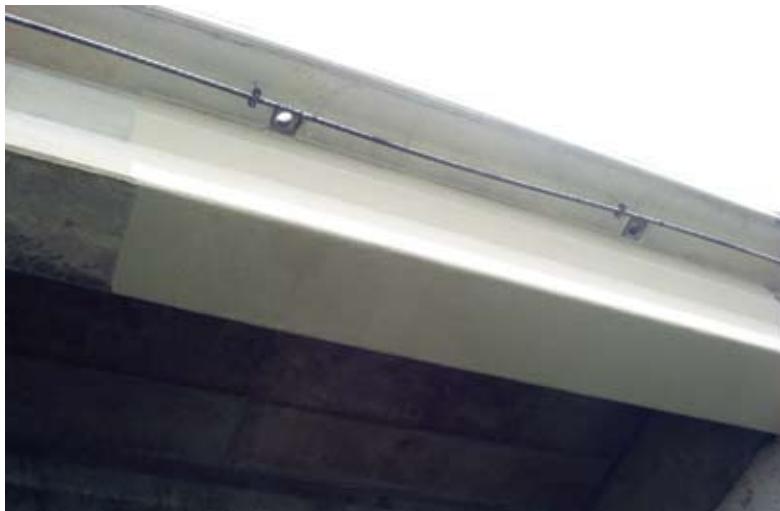
*CFRP with protective coating*

coating. Once the in-place testing verified the required strengths, a water-based acrylic protective coating was applied over all the repairs to help achieve the desired service life of the bridge.
