# *Sunshine Skyway Bridge*

## *Yesterday, Today and Tomorrow*

***May 2006***

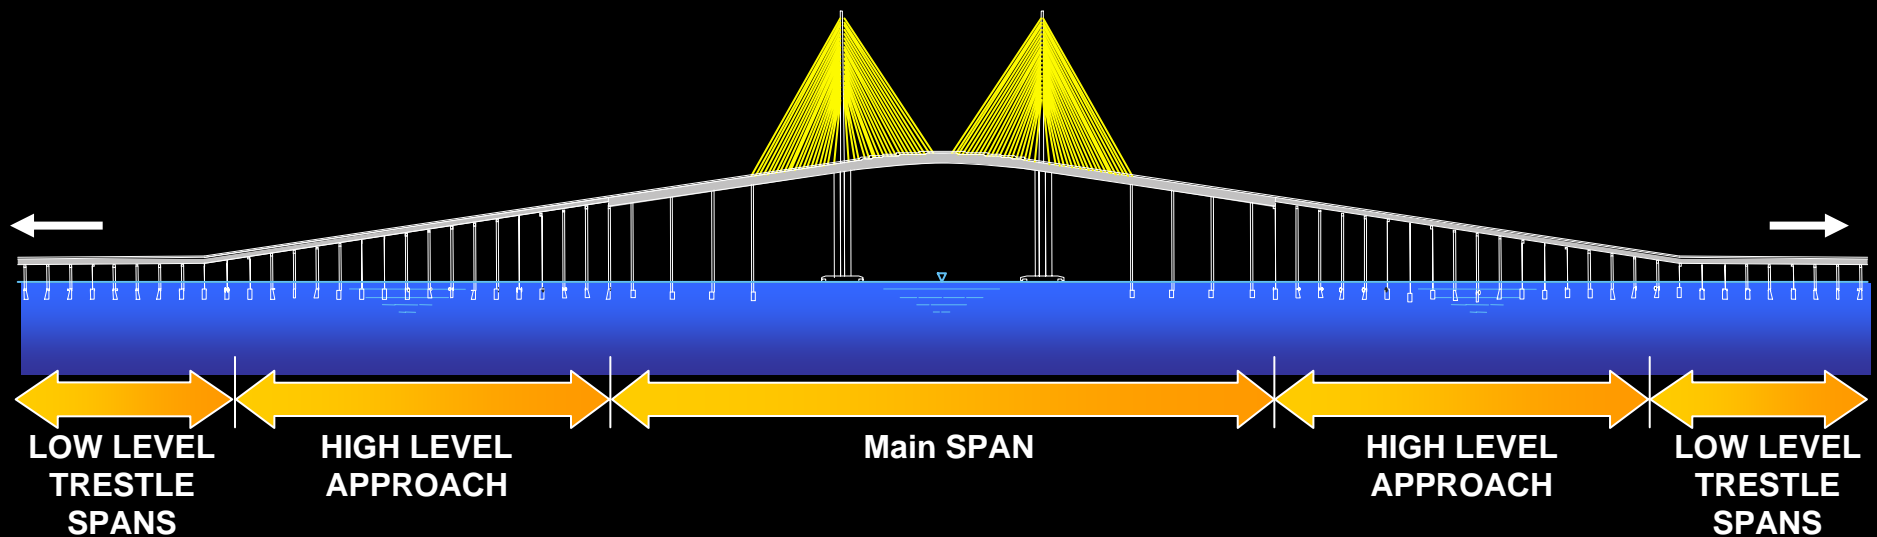
## Bridge Geometry

**Total Bridge length: 4.14 miles**

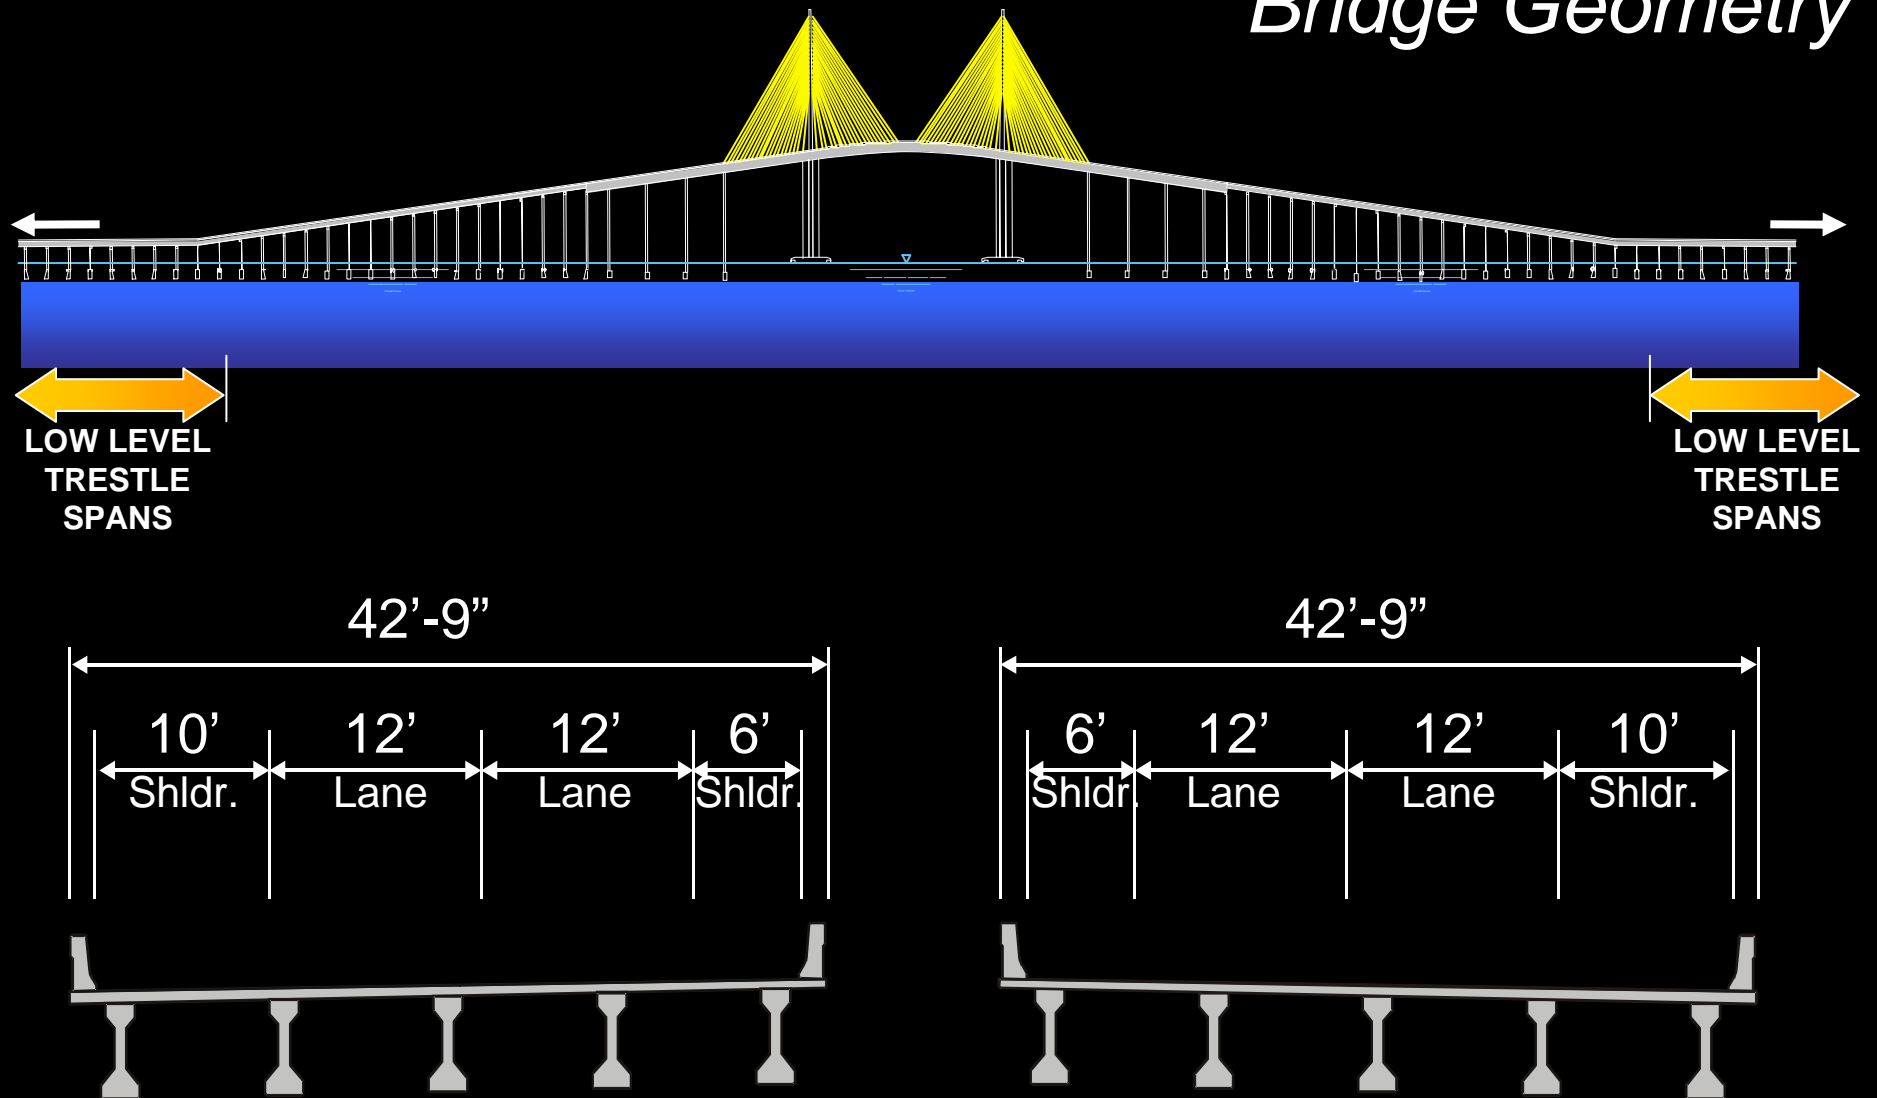
## Bridge Geometry

**Total Length: 13,000 ft**

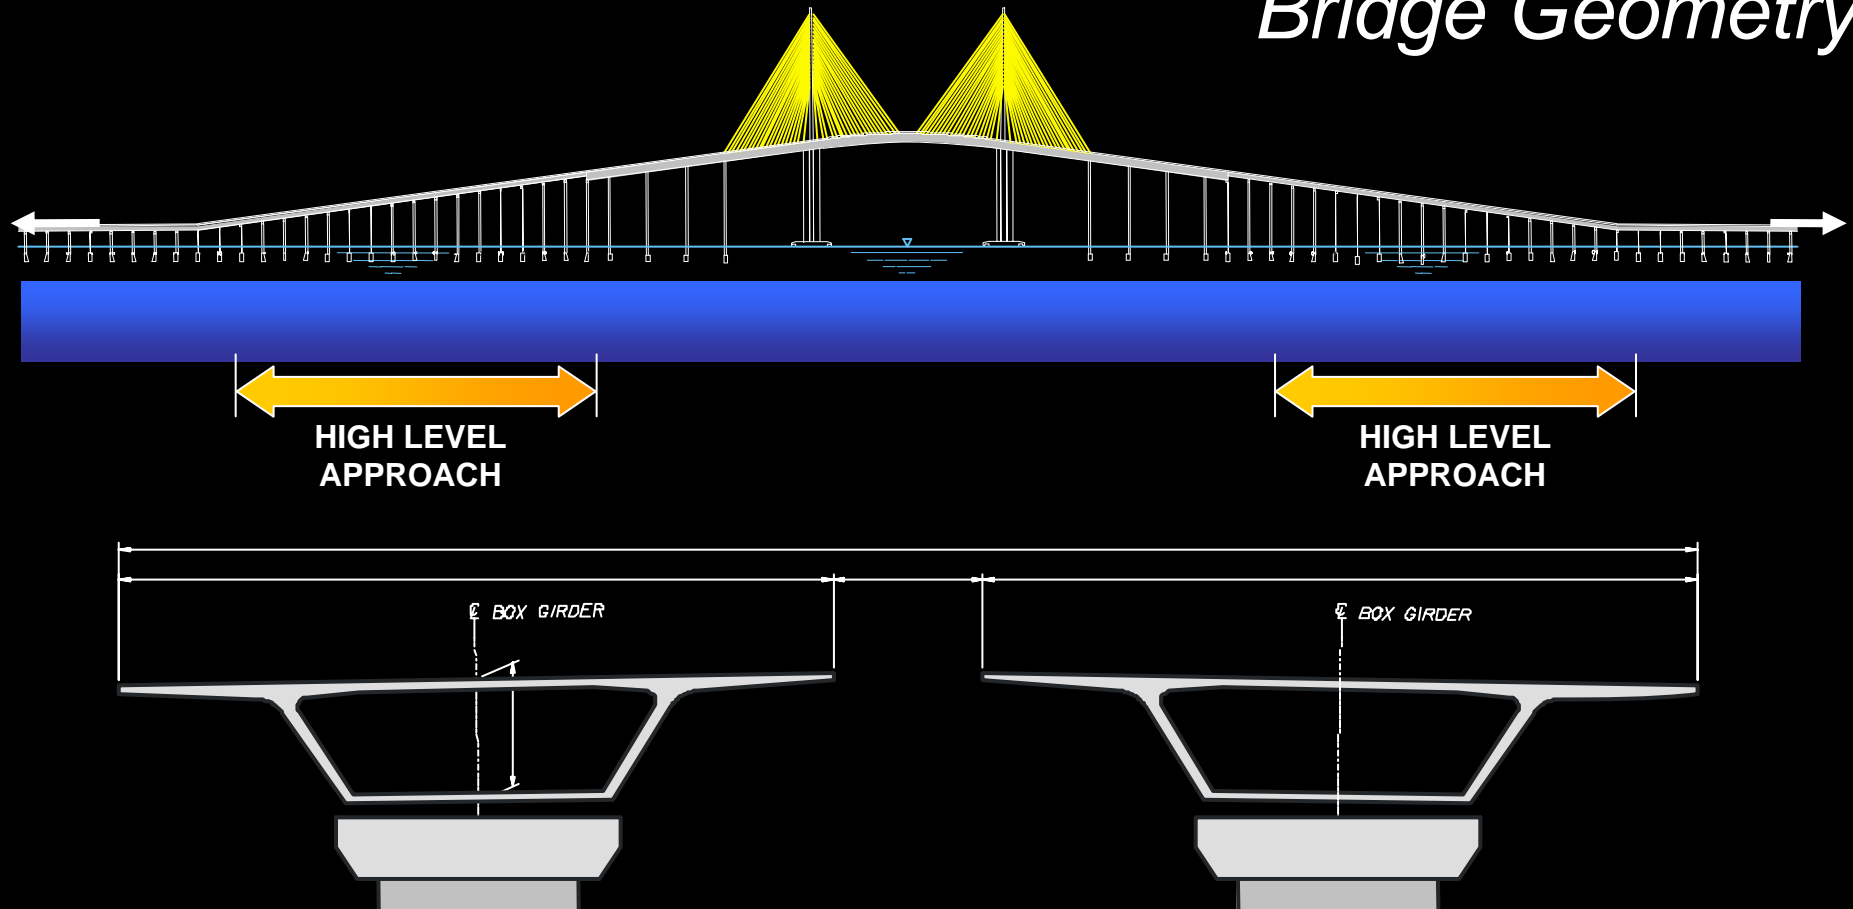
## Bridge Geometry

- **Total length: 5,000 ft**
- **Post-Tensioned Segmental Box Girders**
- **Vertically Post-Tensioned Segmental Columns**

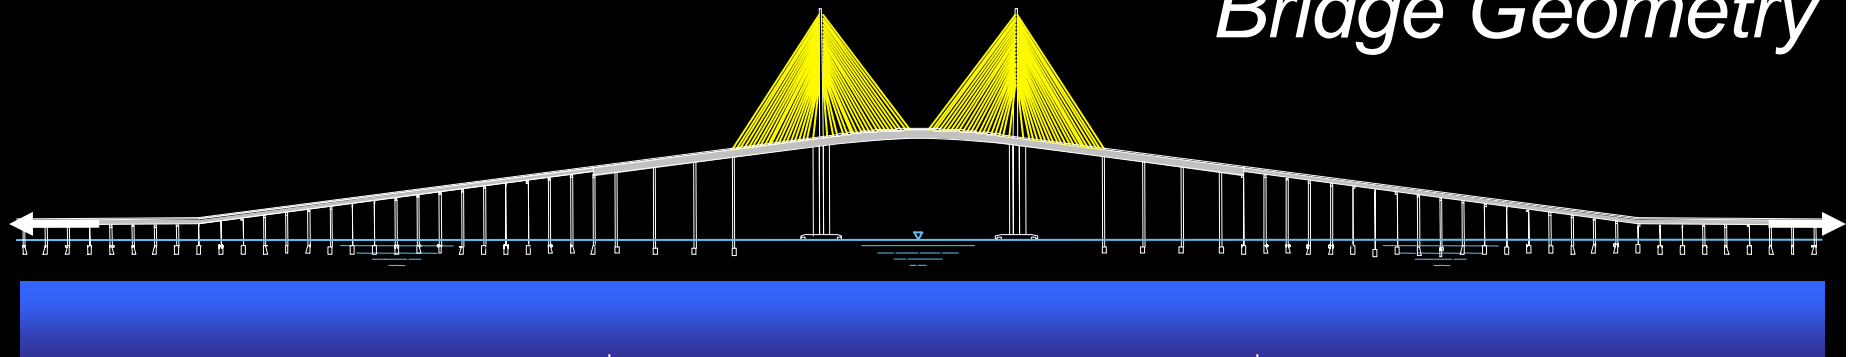
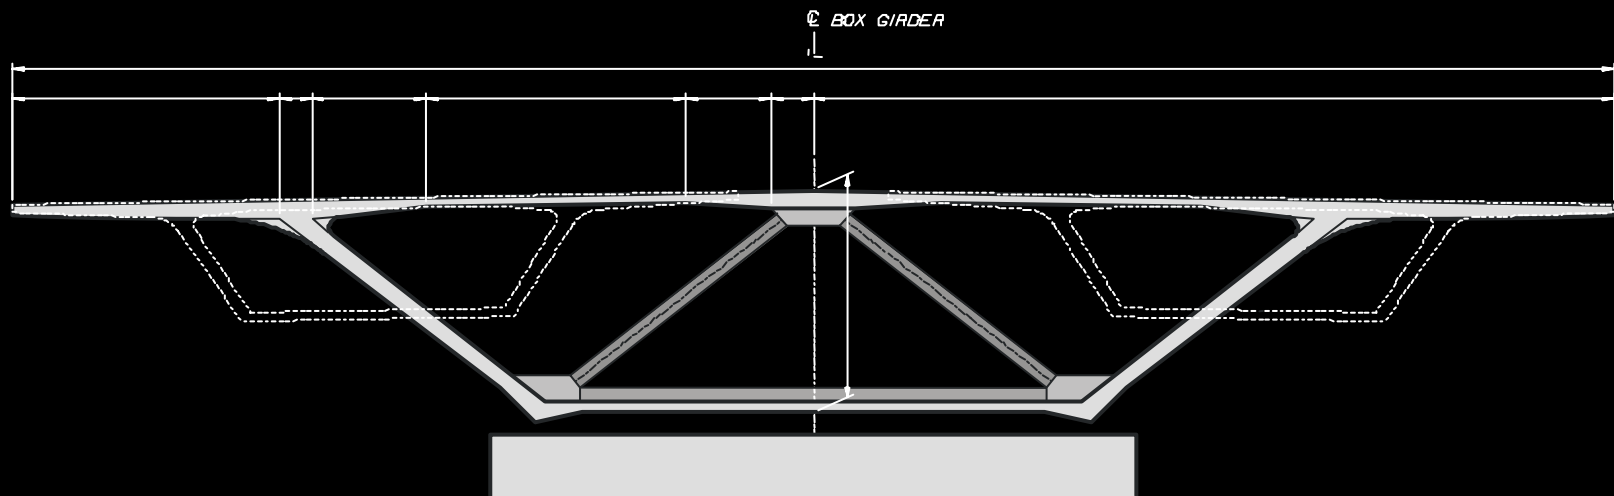
## Bridge Geometry

- **Total length: 4,000 ft**
- **Post-Tensioned Precast Segmental Box**
- **42 Continuous Stay Cables, 21 per Pylon**

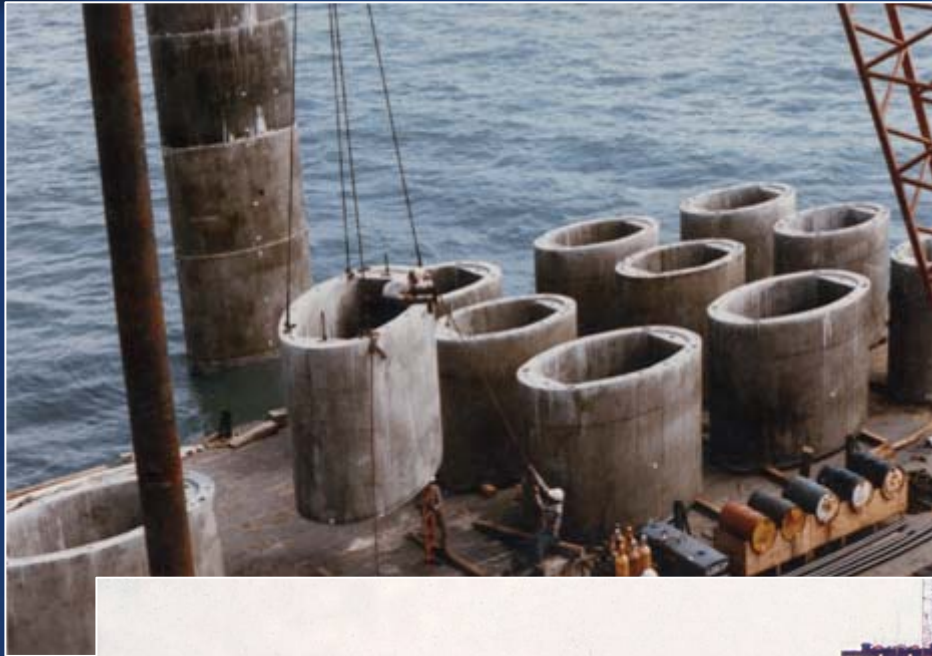
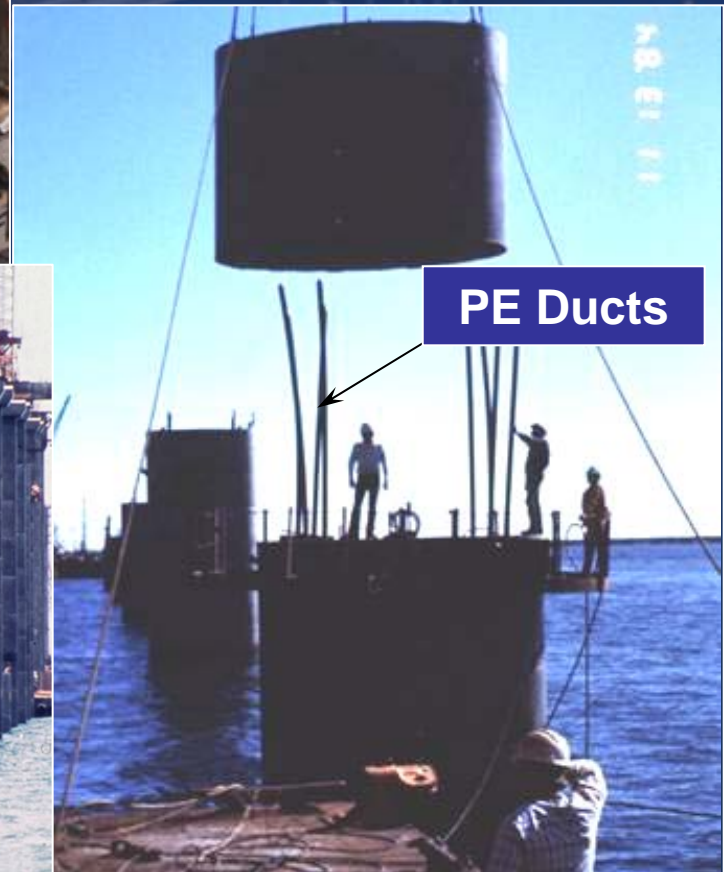
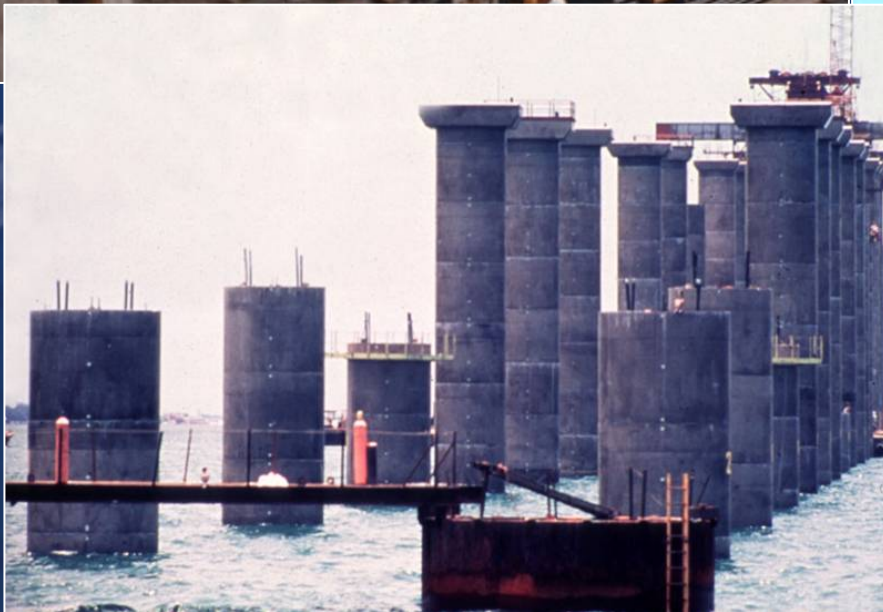
High Level Approaches

Pre-Cast Column

PT Segments

PE Ducts

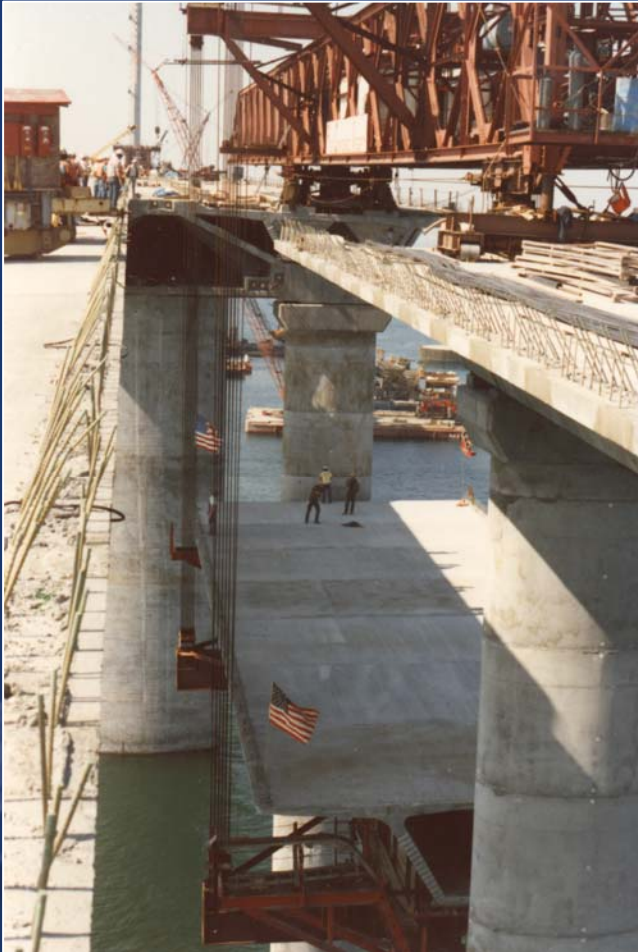
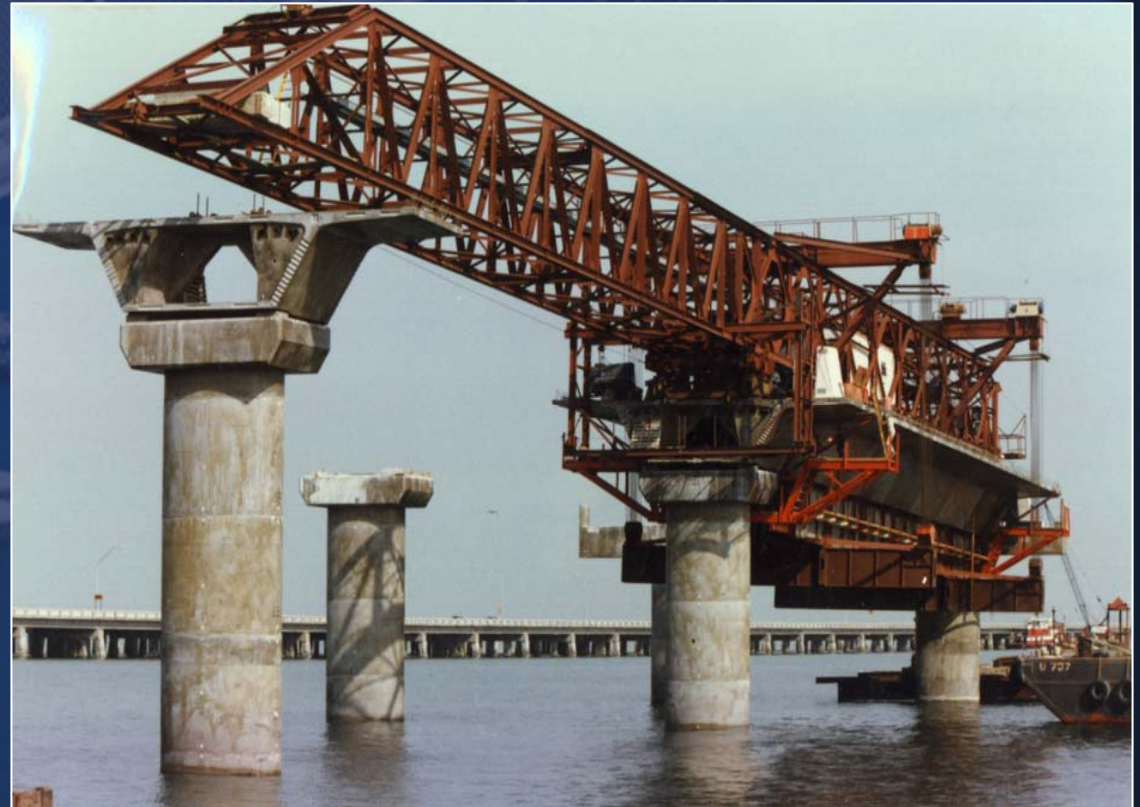
*High Level Approaches  
Superstructure  
PT Segmental Construction*

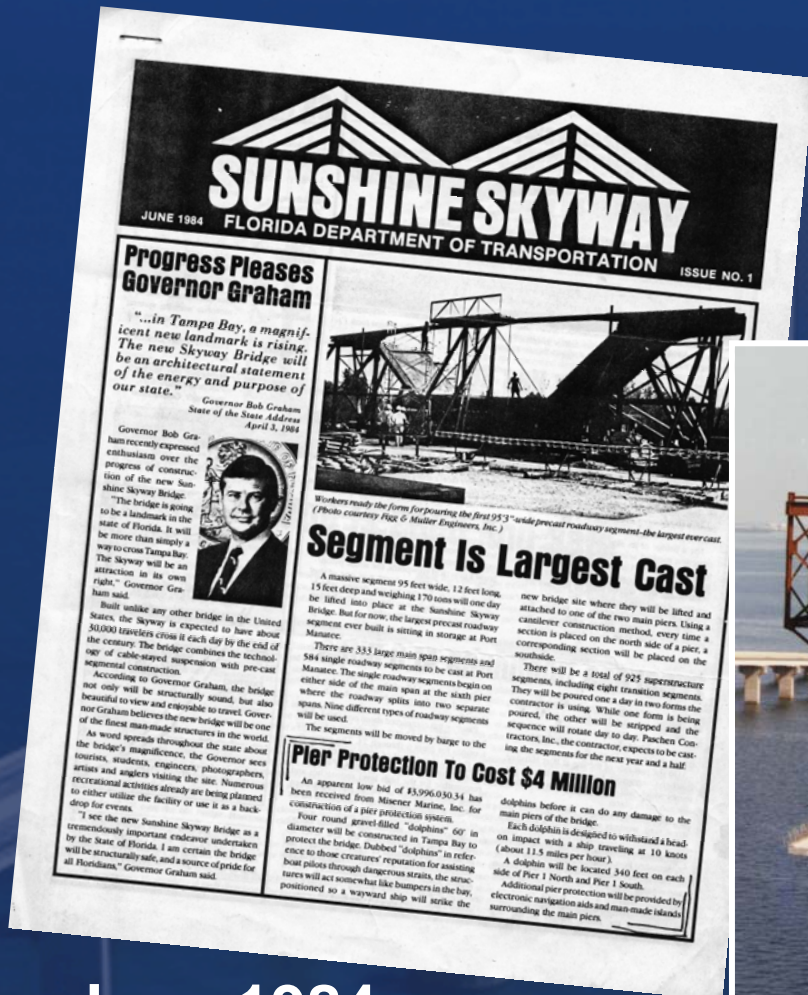
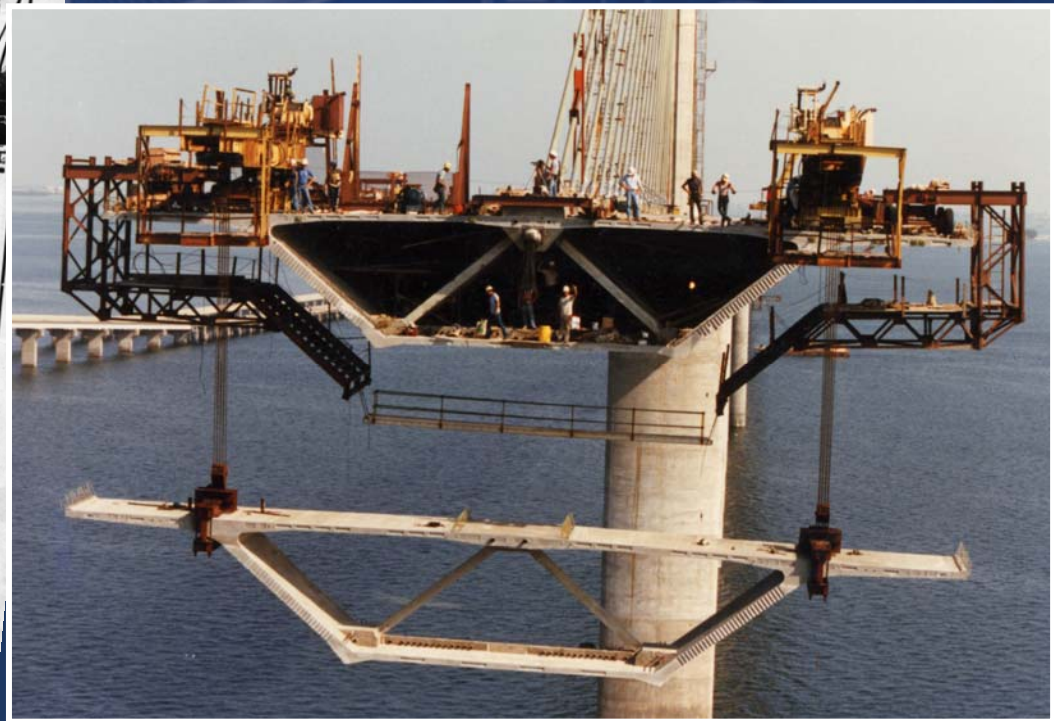
Main Span  
Pre-Cast  
PT Segments

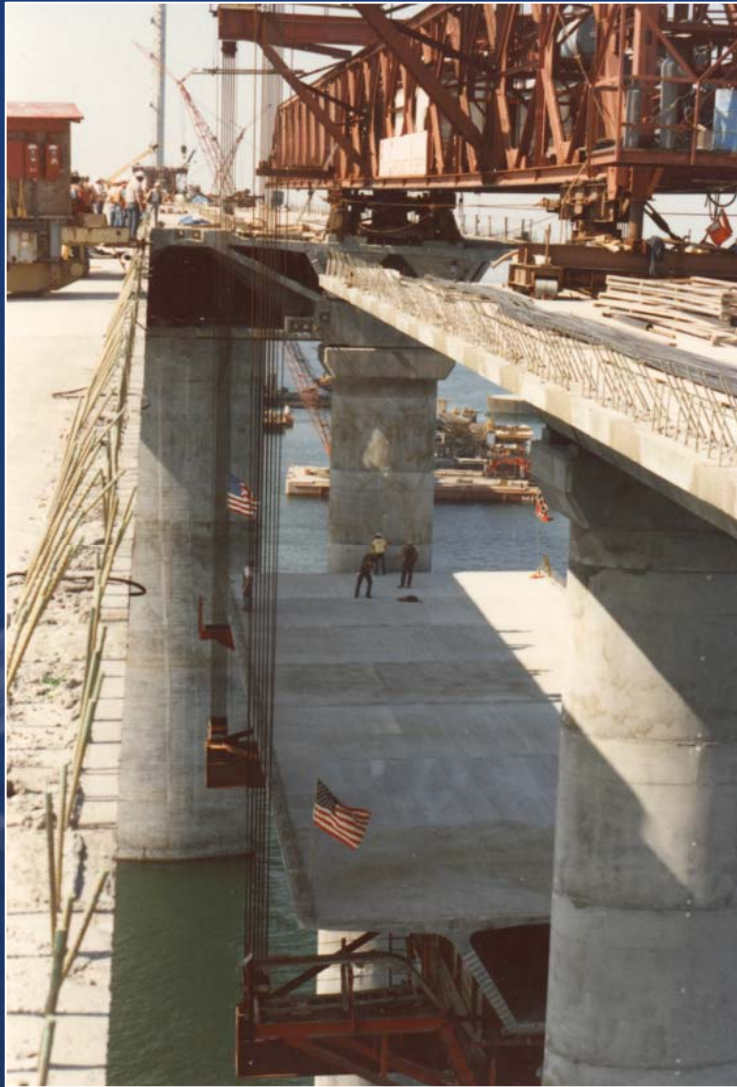
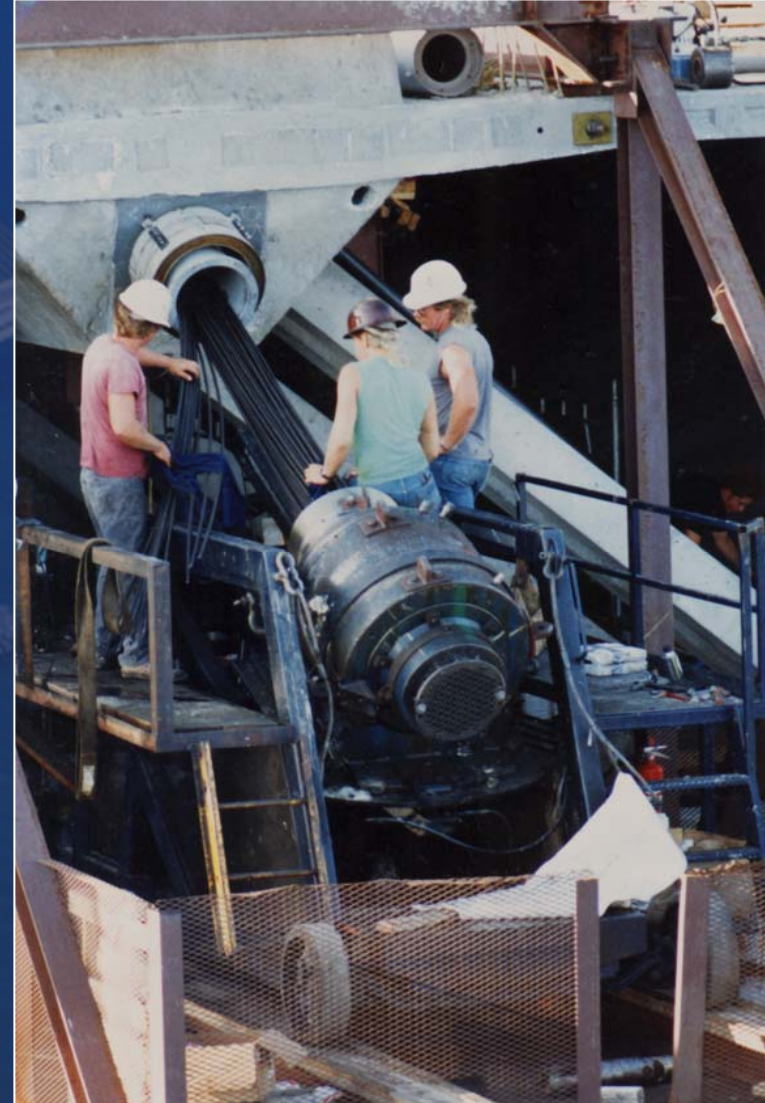
PT Cable Stays

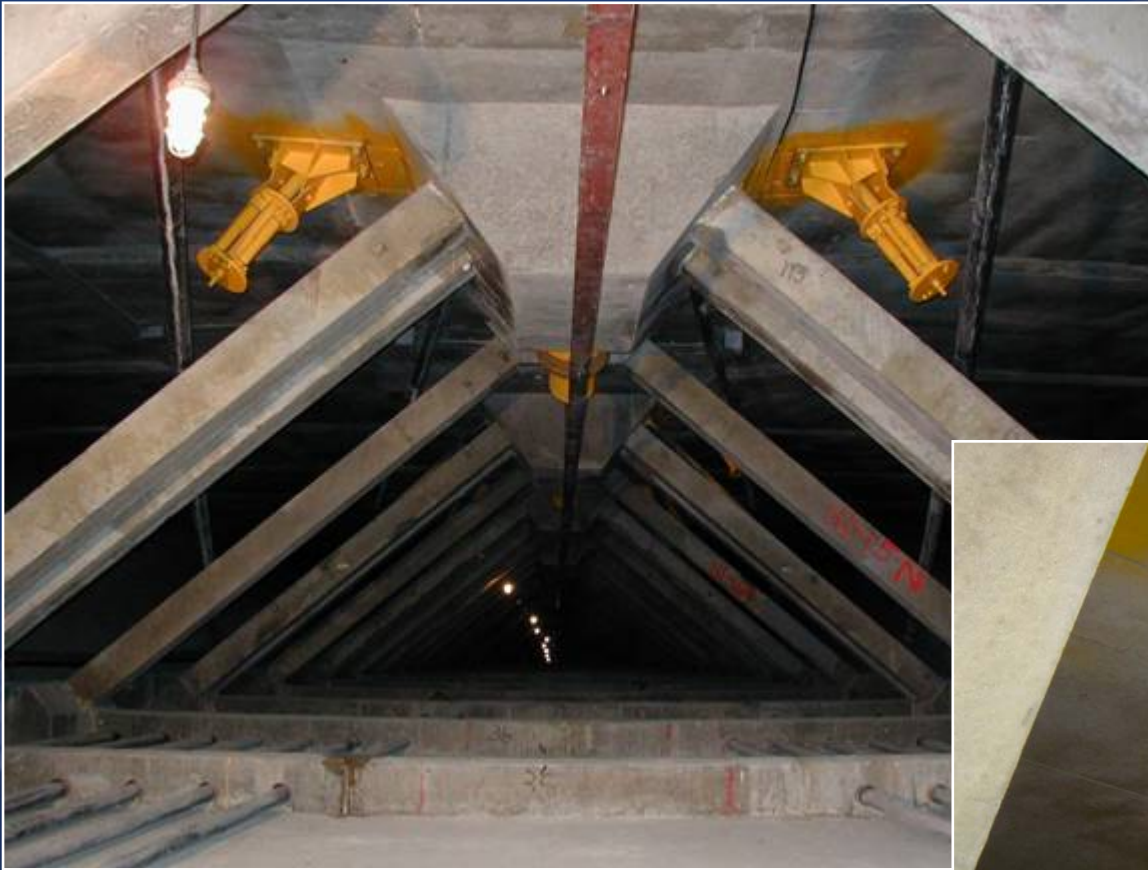
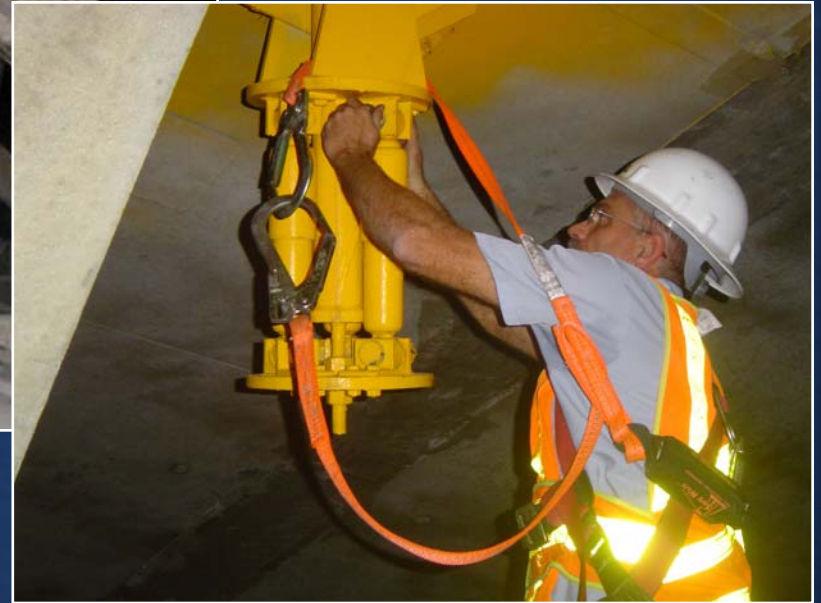
*Stay Cable Dampners*

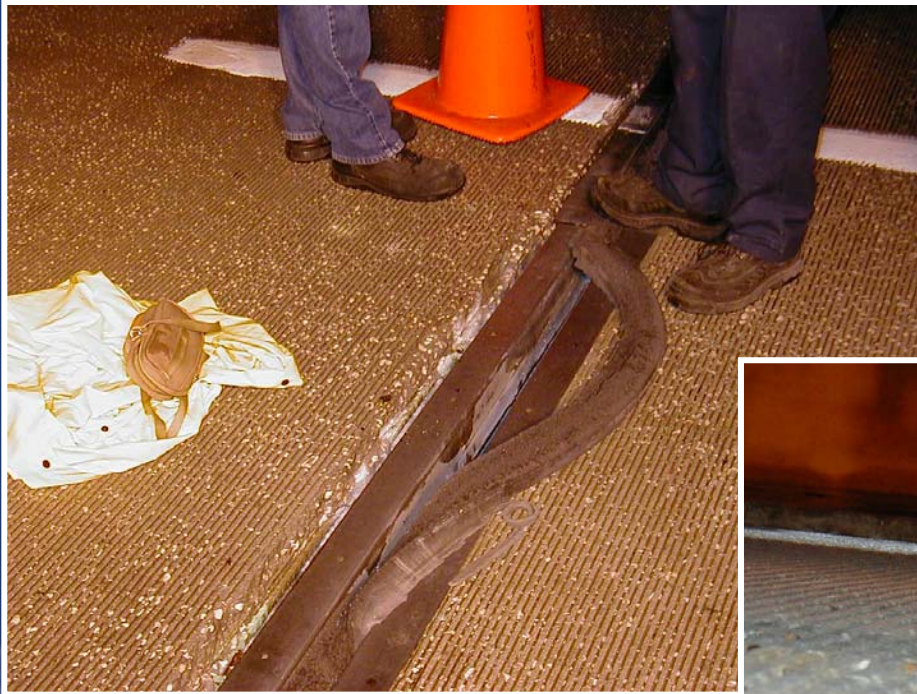
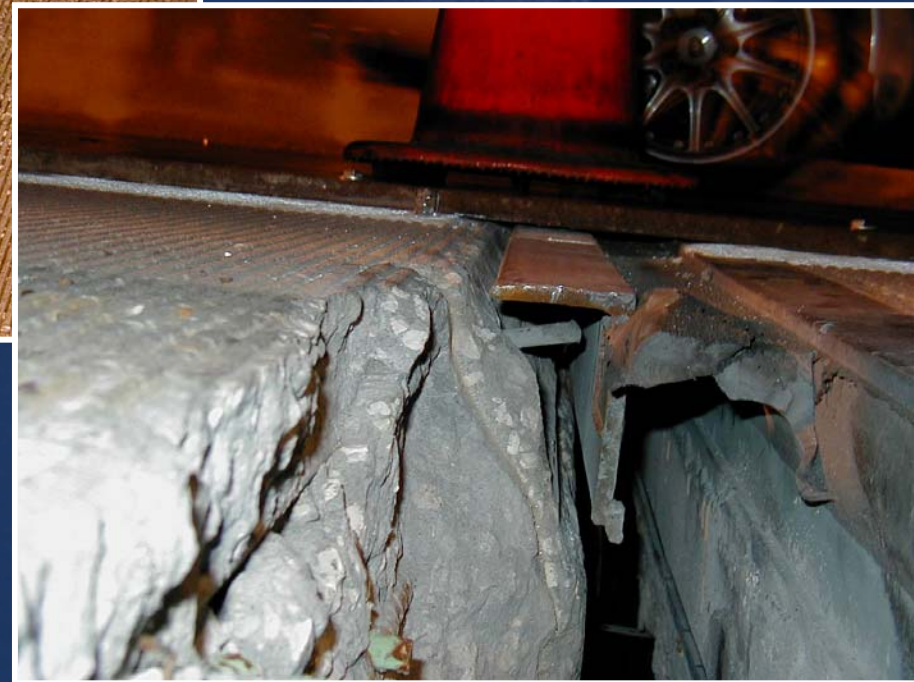
**Armored Joint**

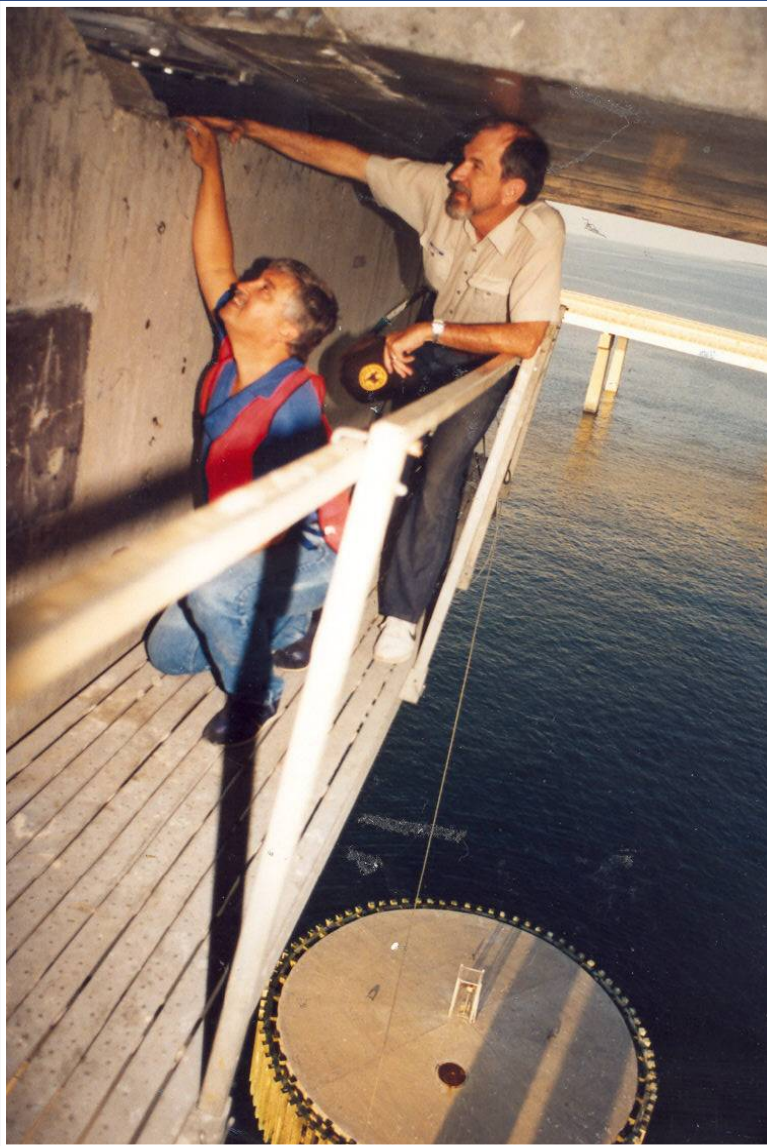
**Teflon Joint  
Replacement 1993**

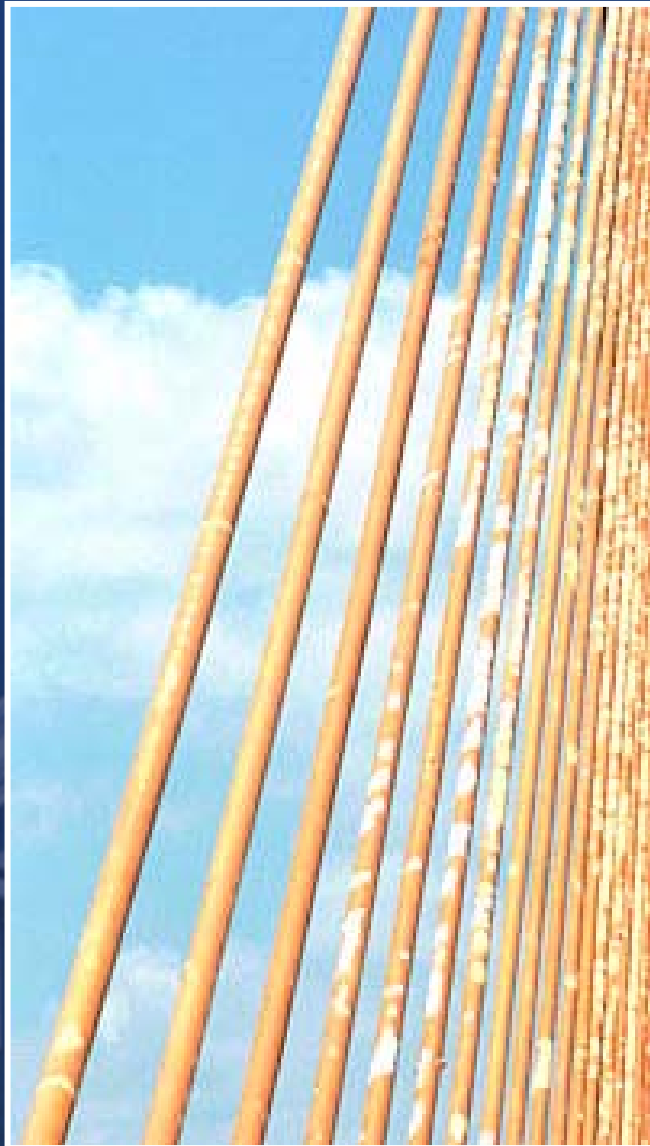
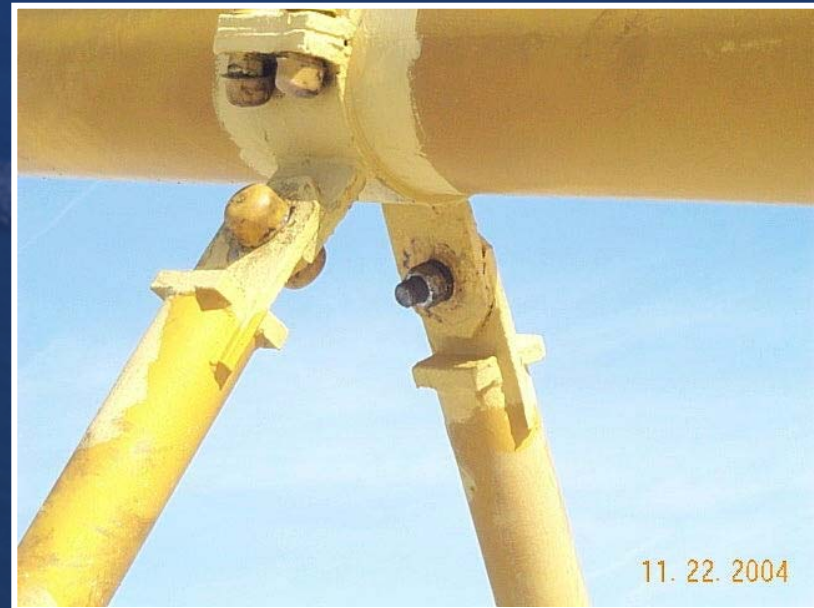
### *Spot Paint Project 1997*

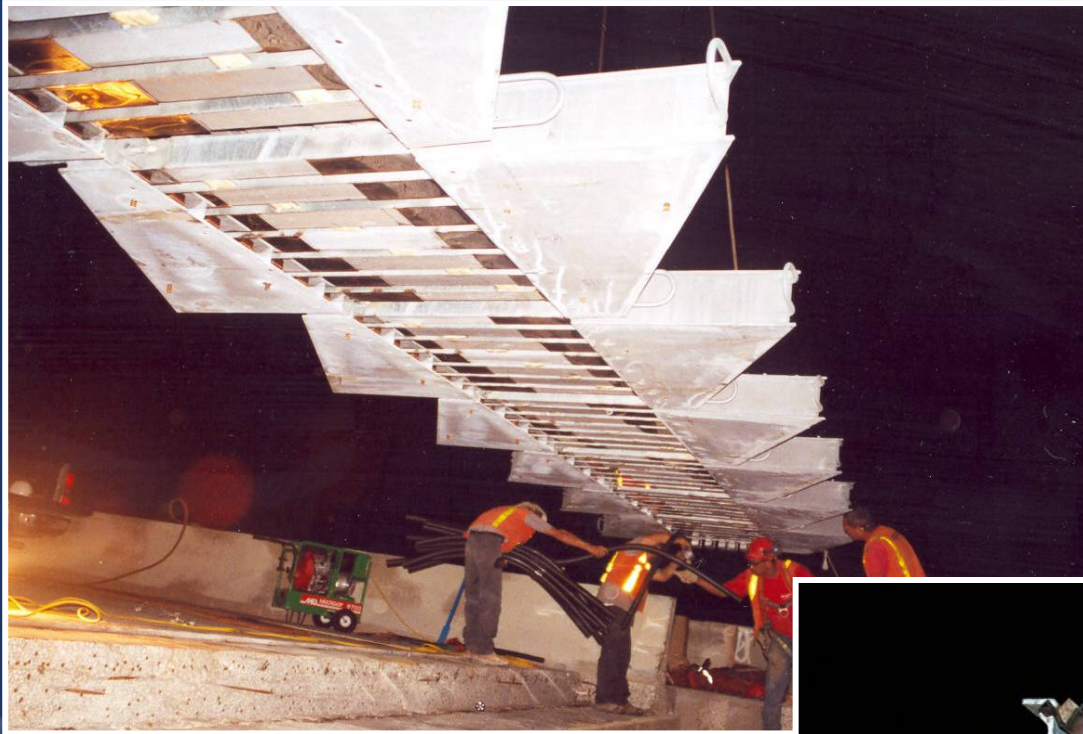
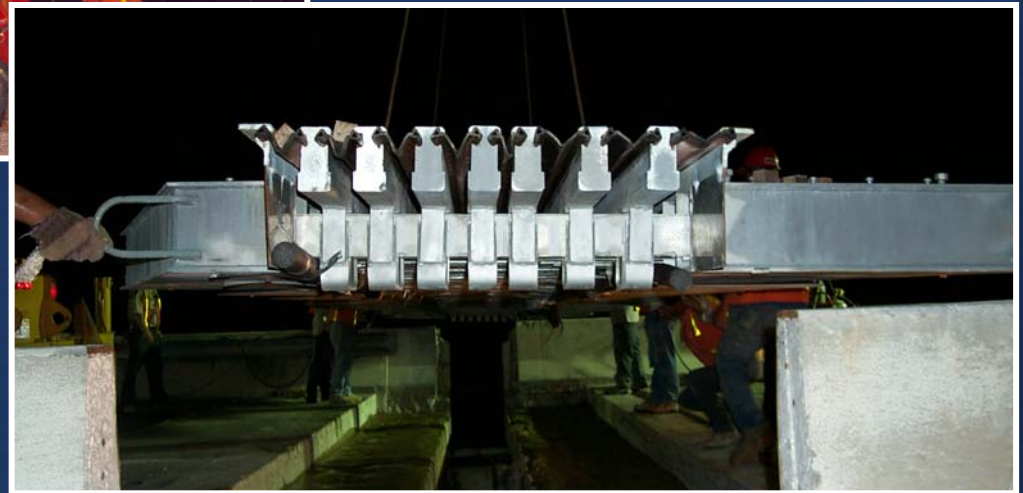
*Modular Joint Replacement*

*2001*

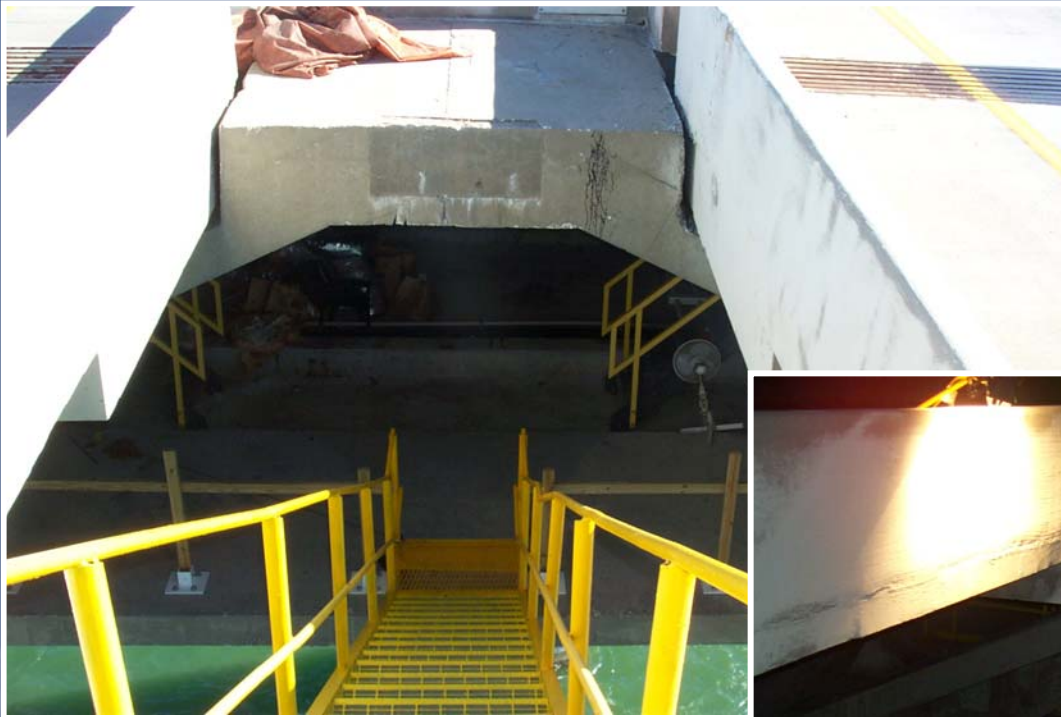
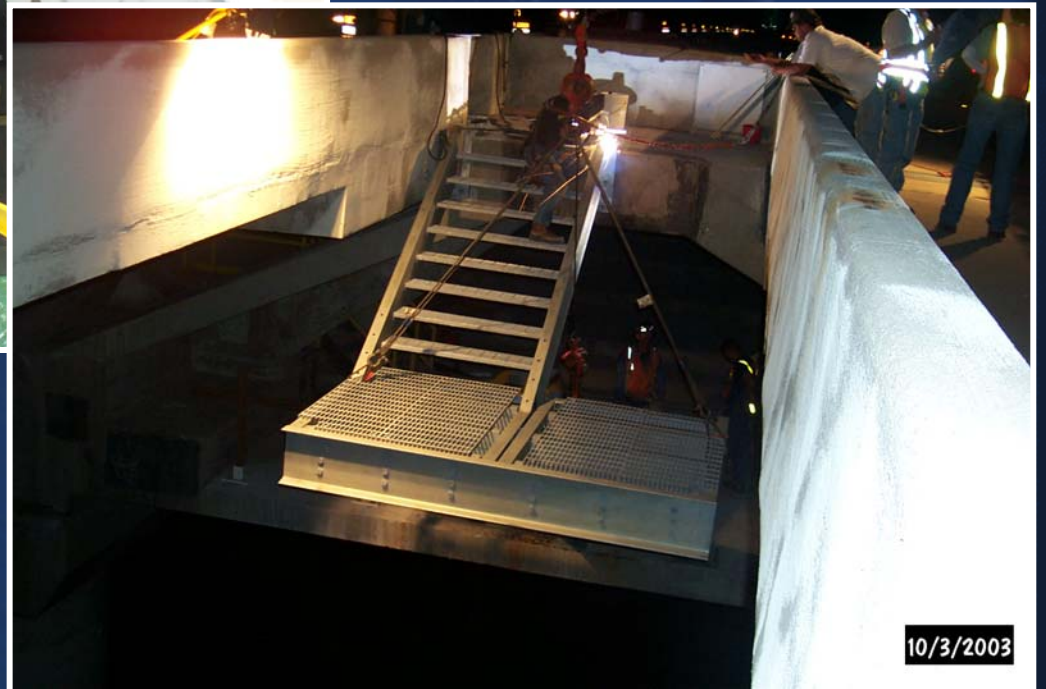
*Access Stairs  
Segmental Transition  
2003*

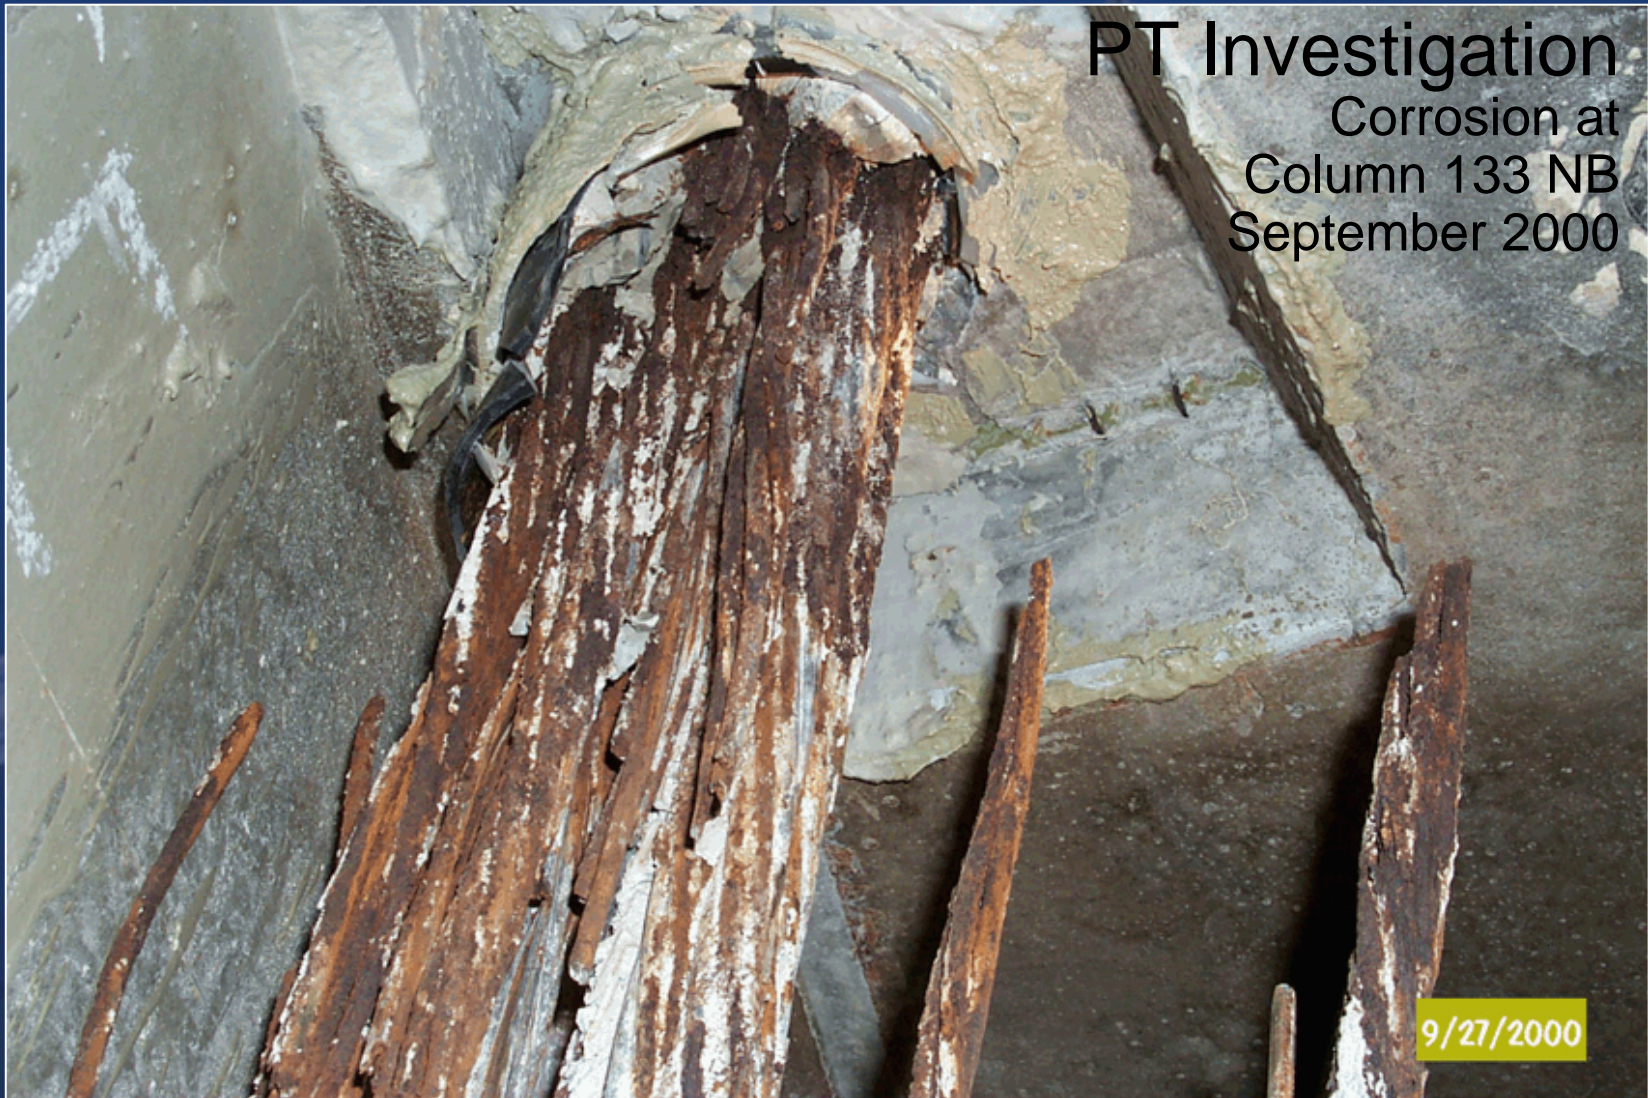
PT Investigation  
Corrosion at  
Column 133 NB  
September 2000

- Tendon Corrosion
- Tendon Failures
- Split/Crack PE Duct
- Grout Voids
- Contaminated Grout
- Salt Water in Hollow Columns
- Segmental Joint Leaks
- Concrete cracks
- Suspect PE Duct Quality
