# *Sunshine Skyway Bridge*

## *Yesterday, Today and Tomorrow*

***May 2006***

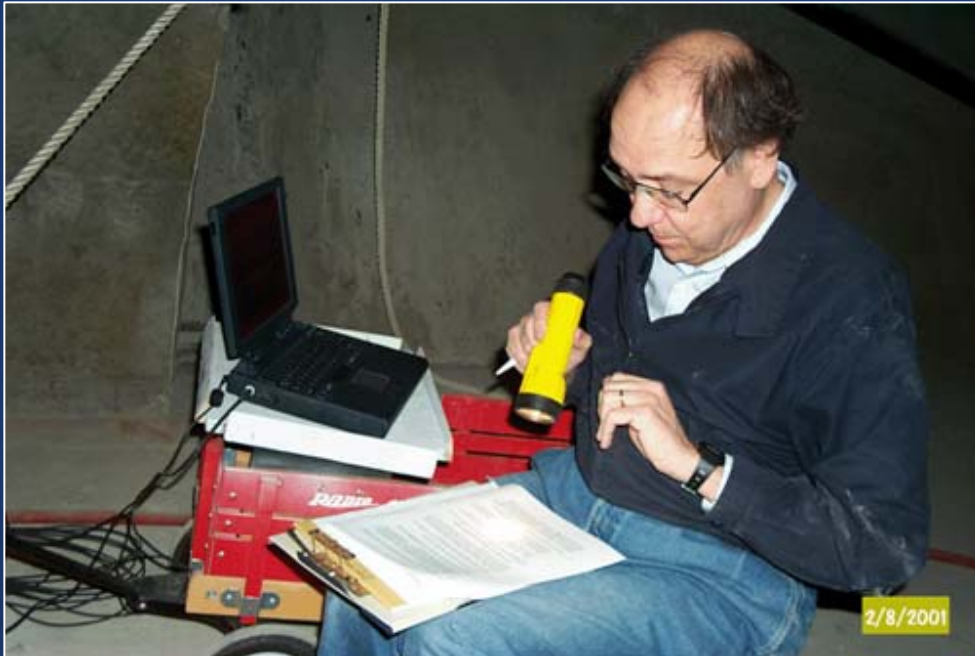
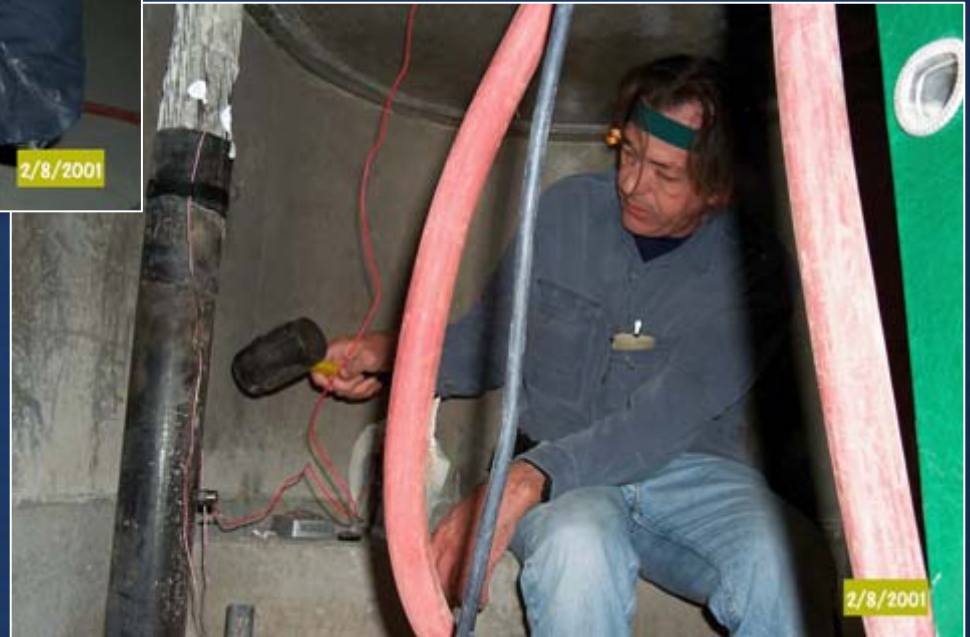
*NDT- Non-Destructive Testing*

*PT Tendon Vibration Testing*

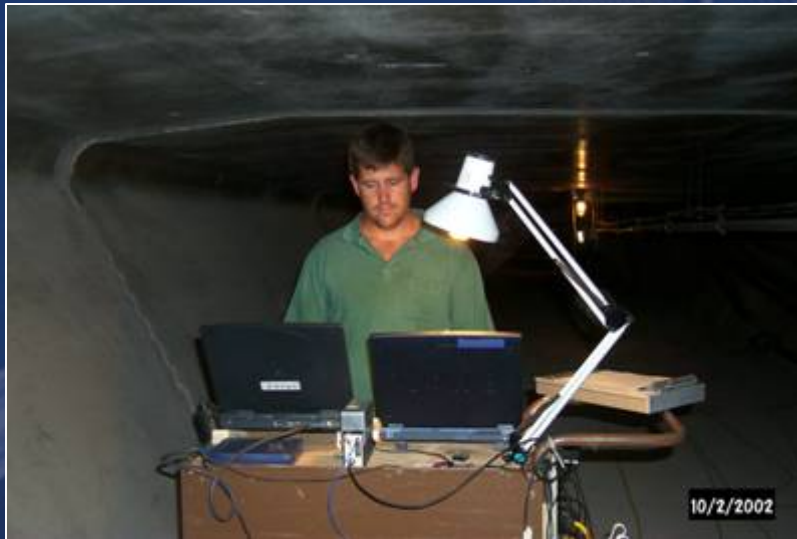
*High Level Approach  
Superstructure Inspection*

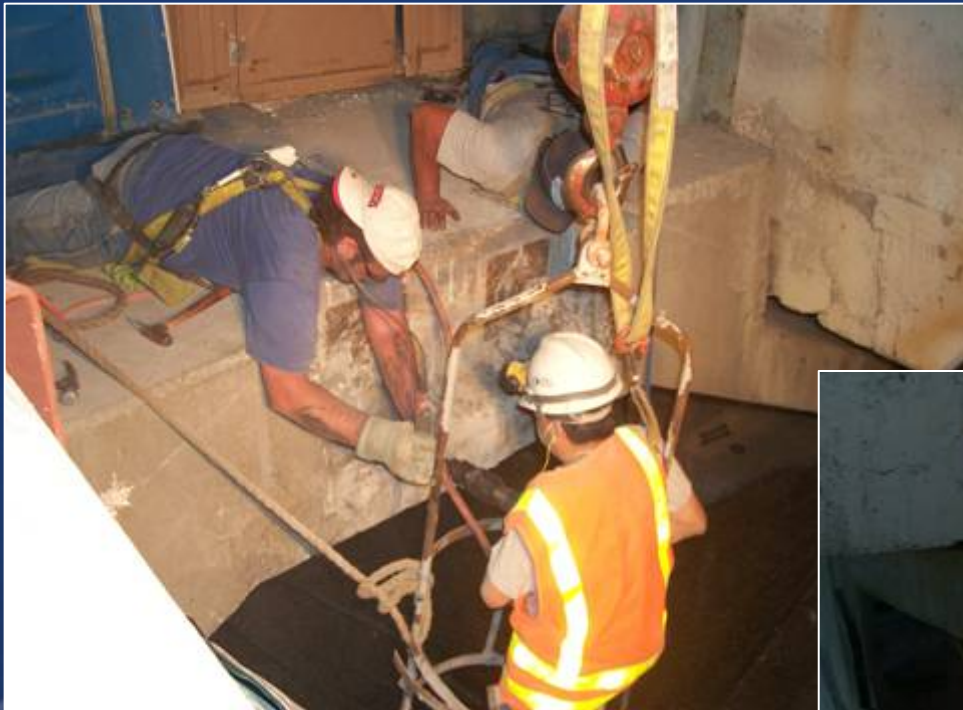
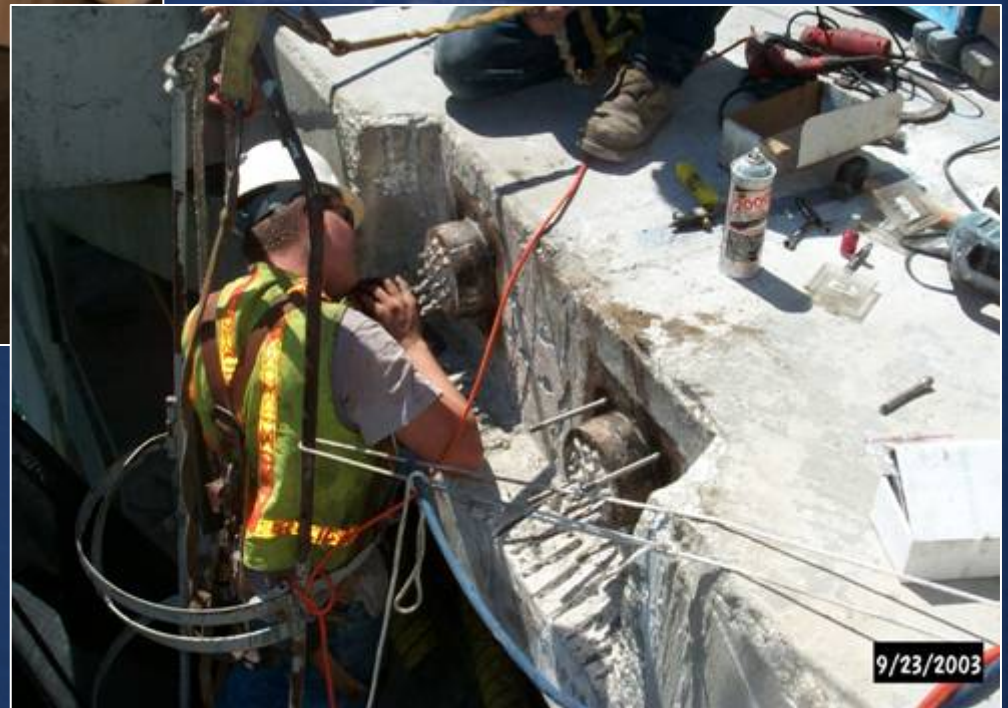
*Main Span  
Superstructure  
Inspection*

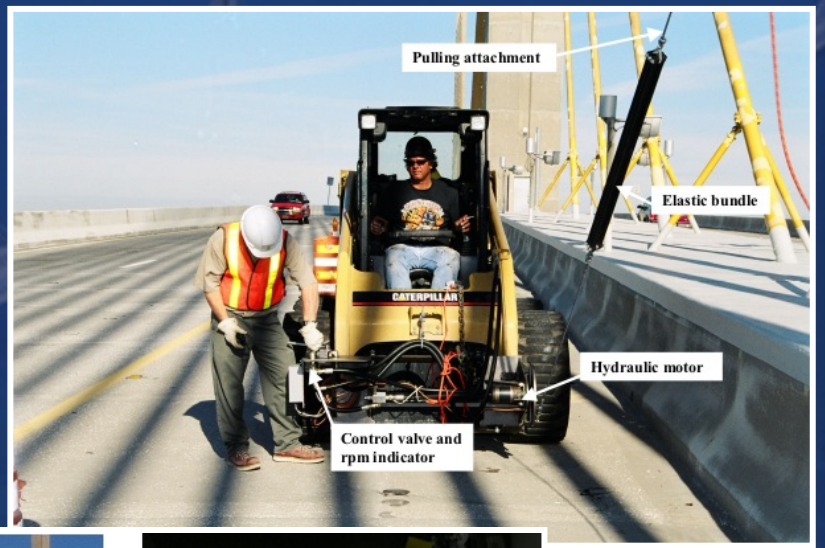
Stay Cables  
Vibration Testing

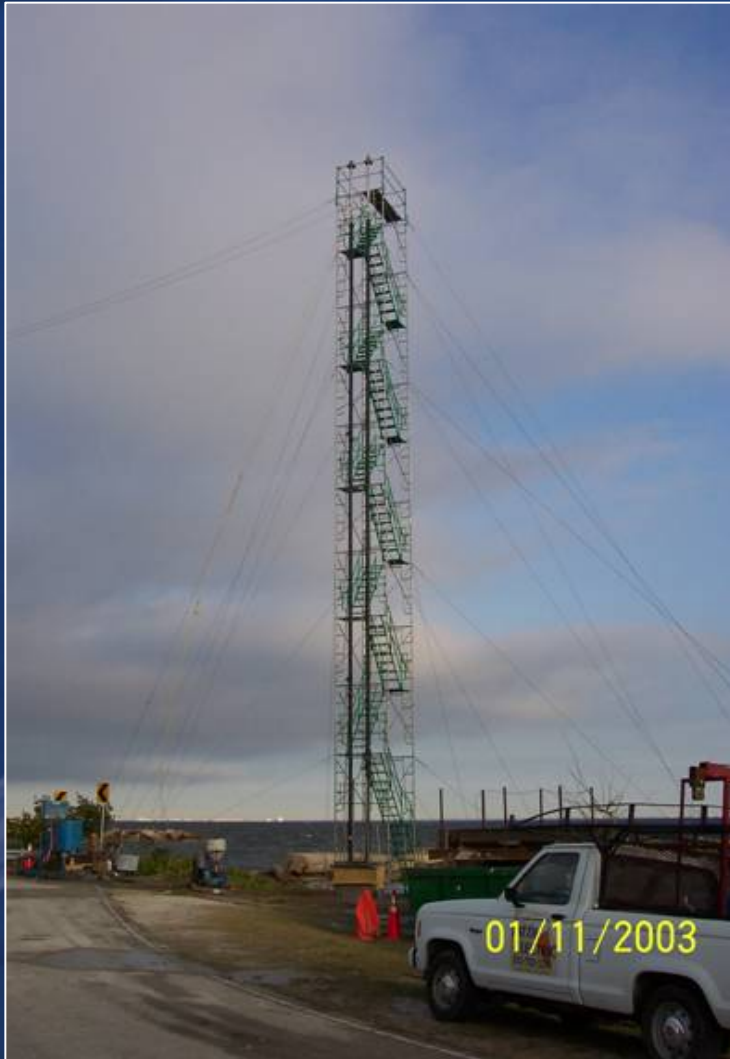
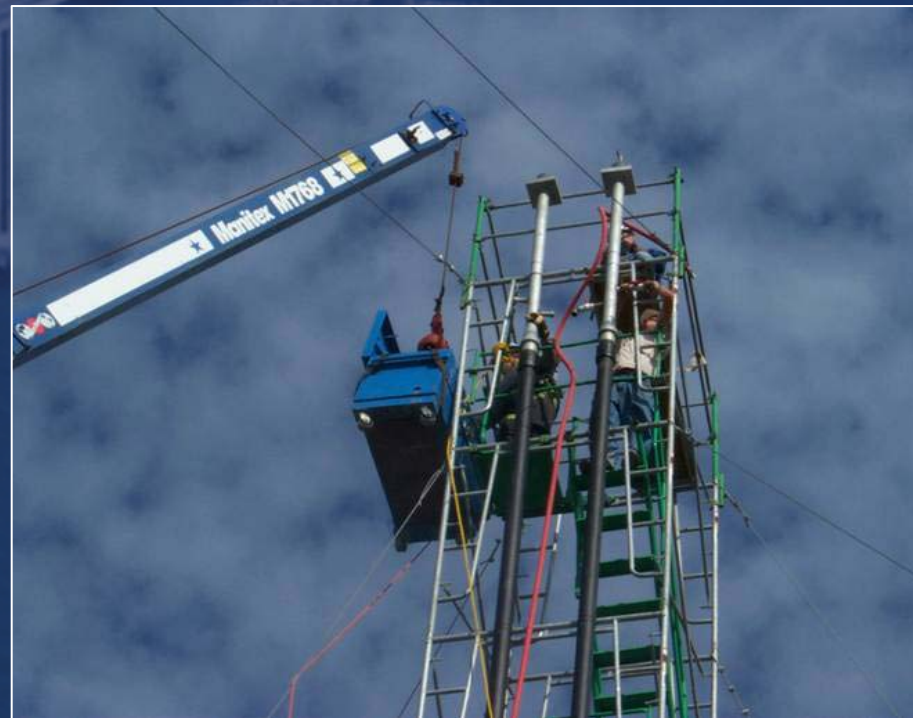
*Vertical Tendon Grouting  
Mock-Up Test Set-Up*

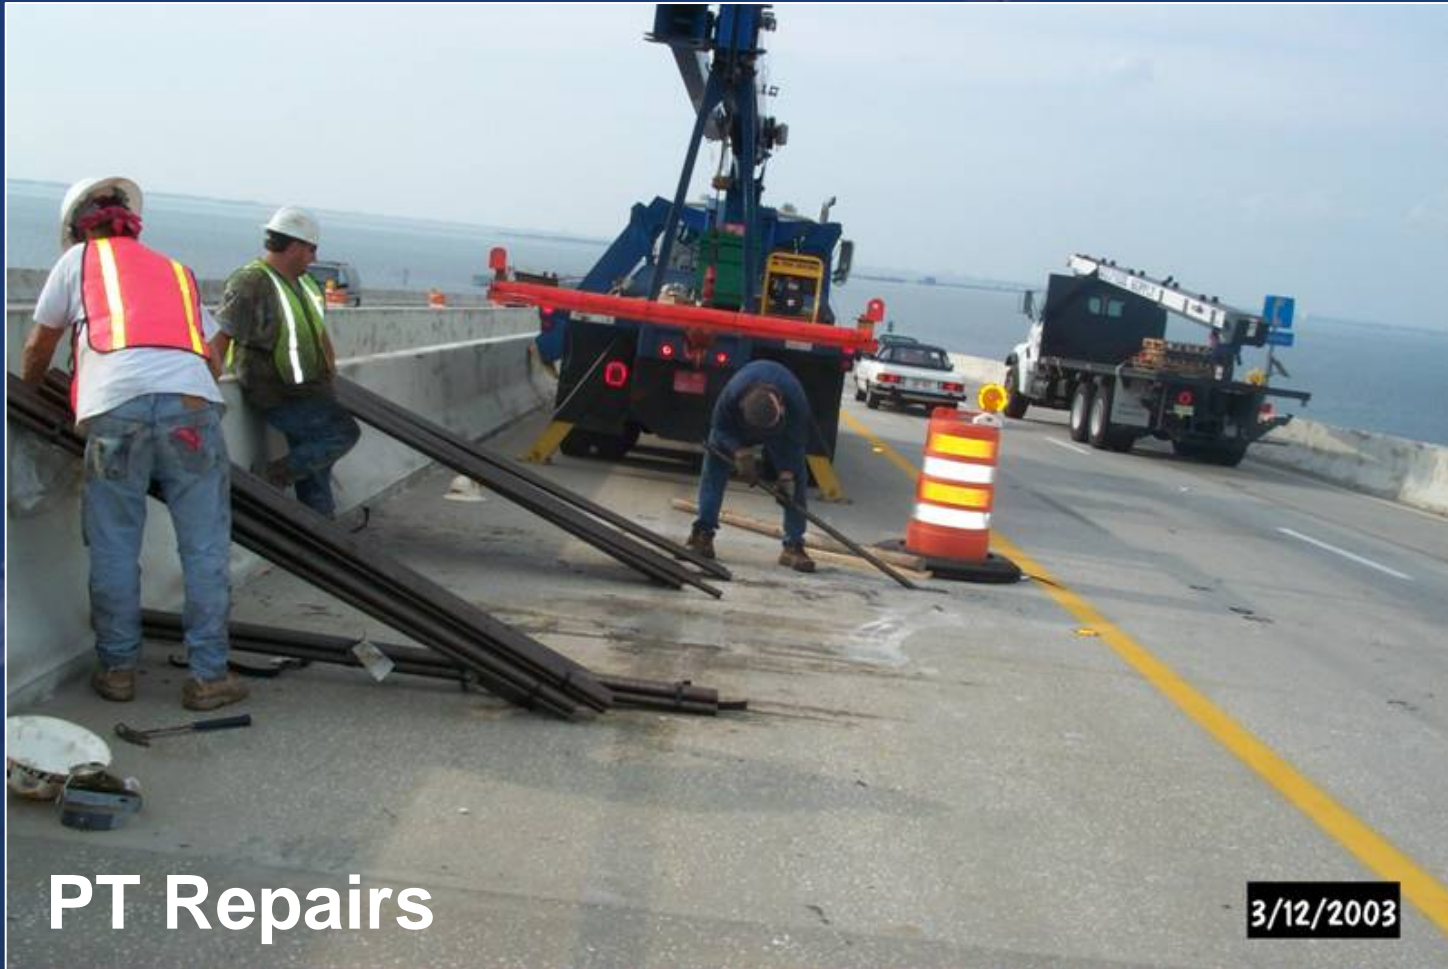
*Inserting Bars into Box Girder*

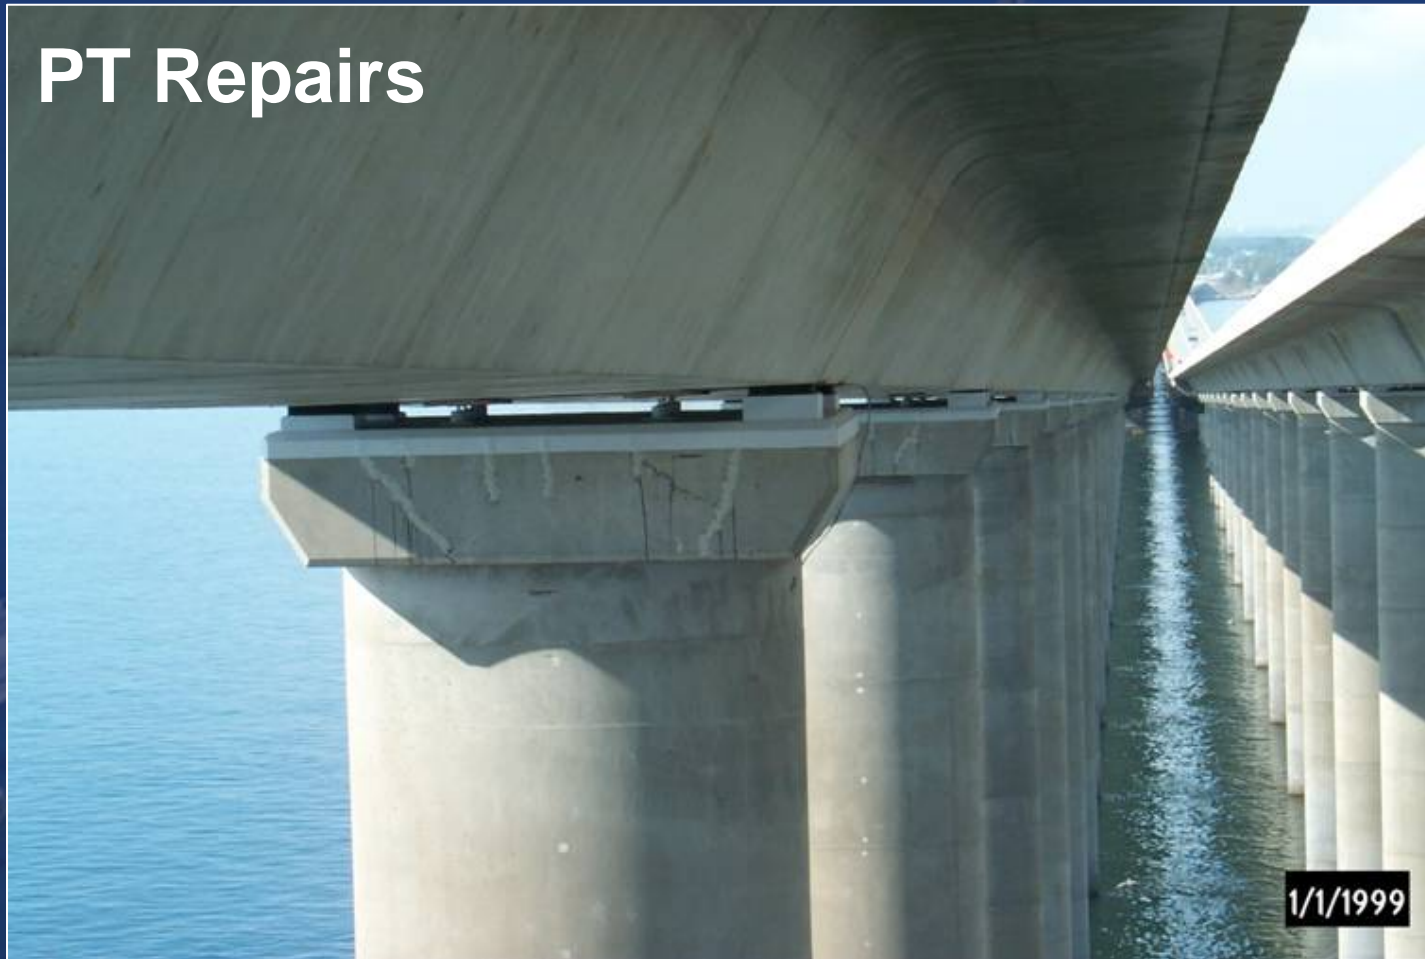
*Pier Cap Coating and Crack Injection*

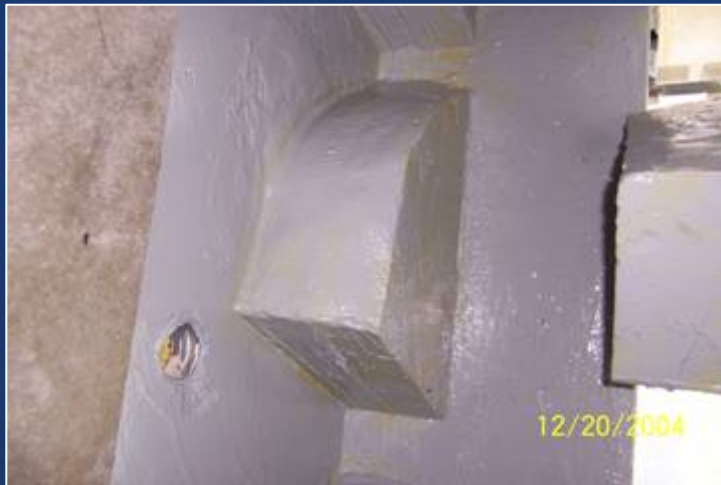
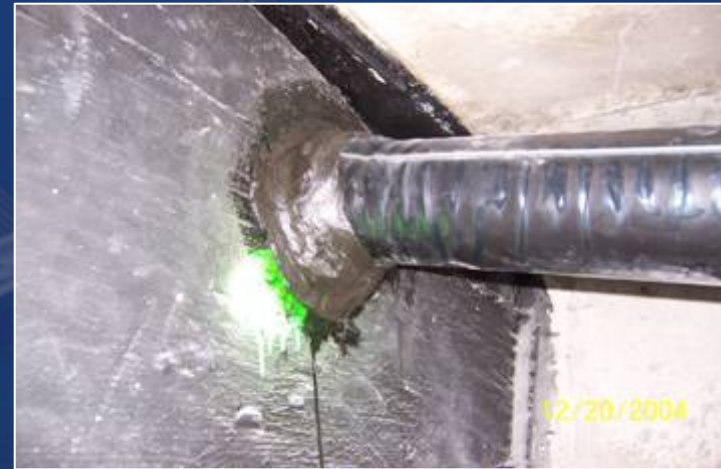
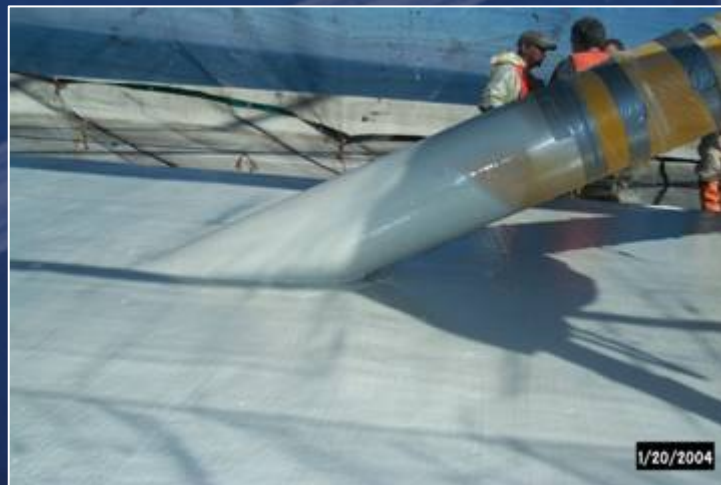
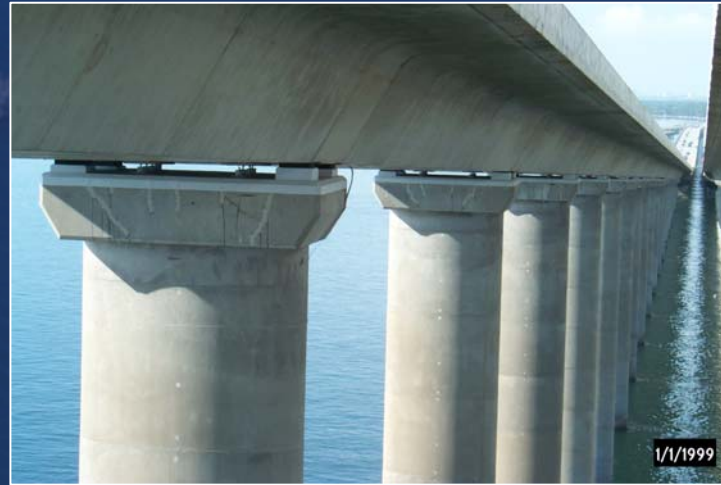
**Protective Sealing Repair**

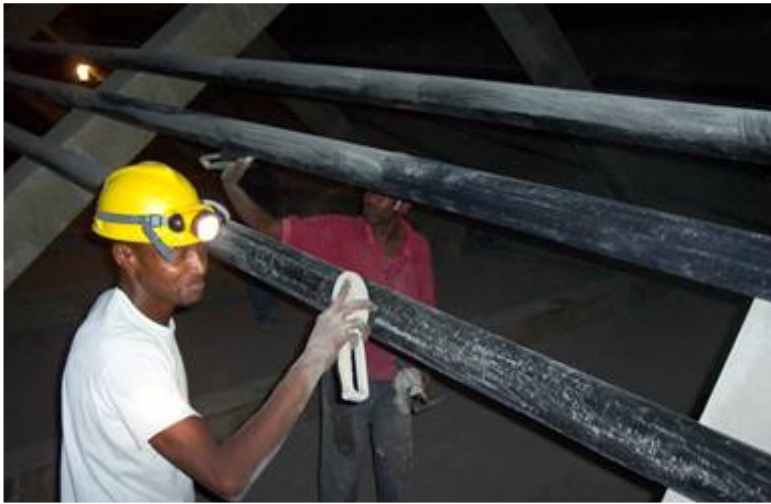
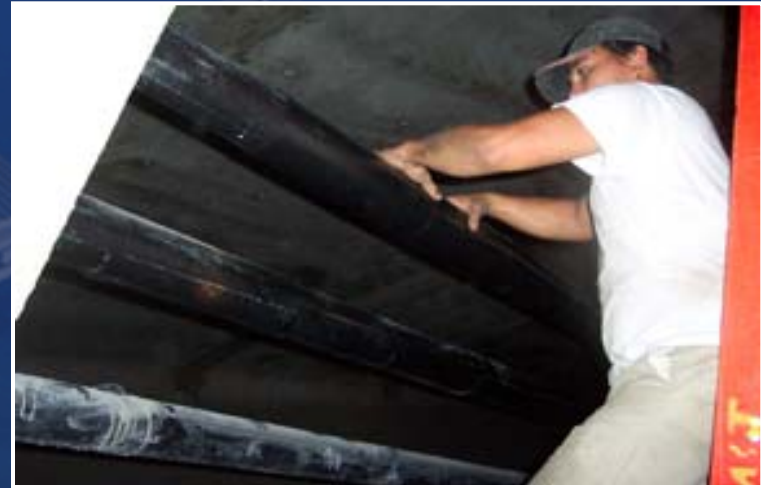
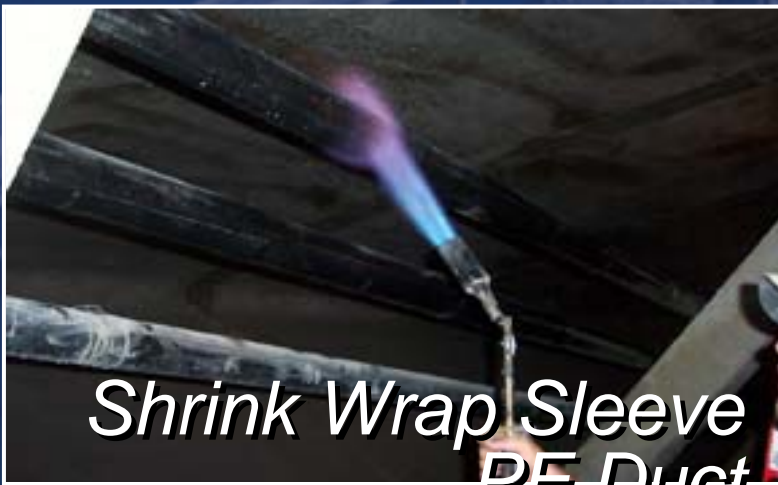
*Shrink Wrap Sleeve  
PE Duct*

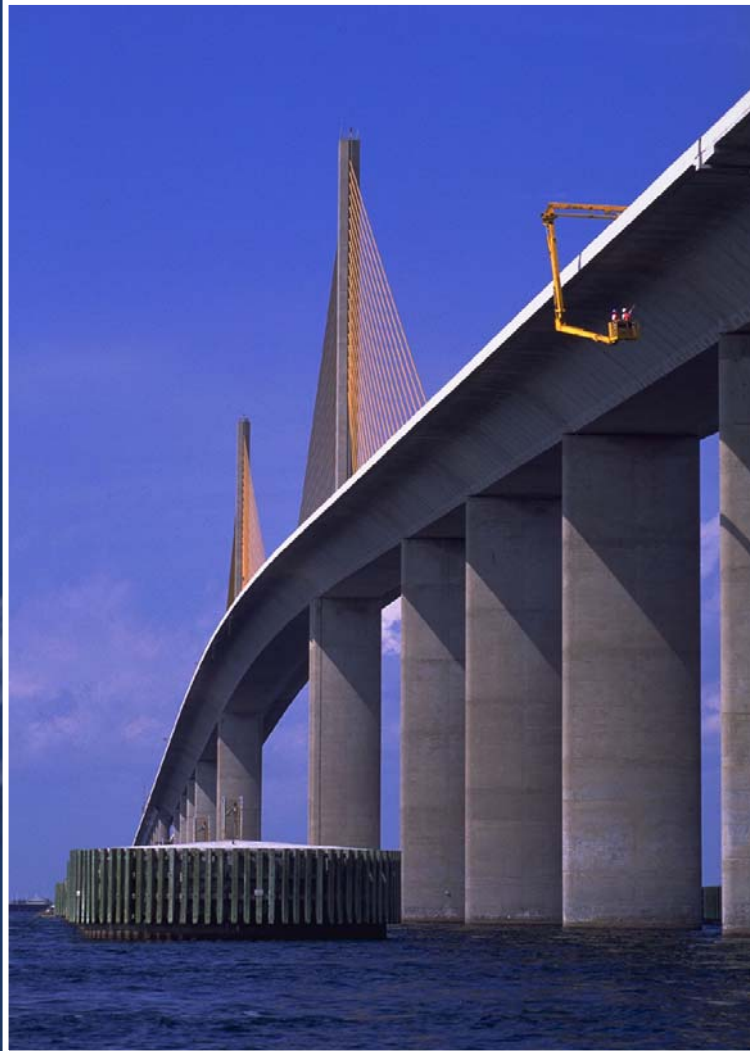
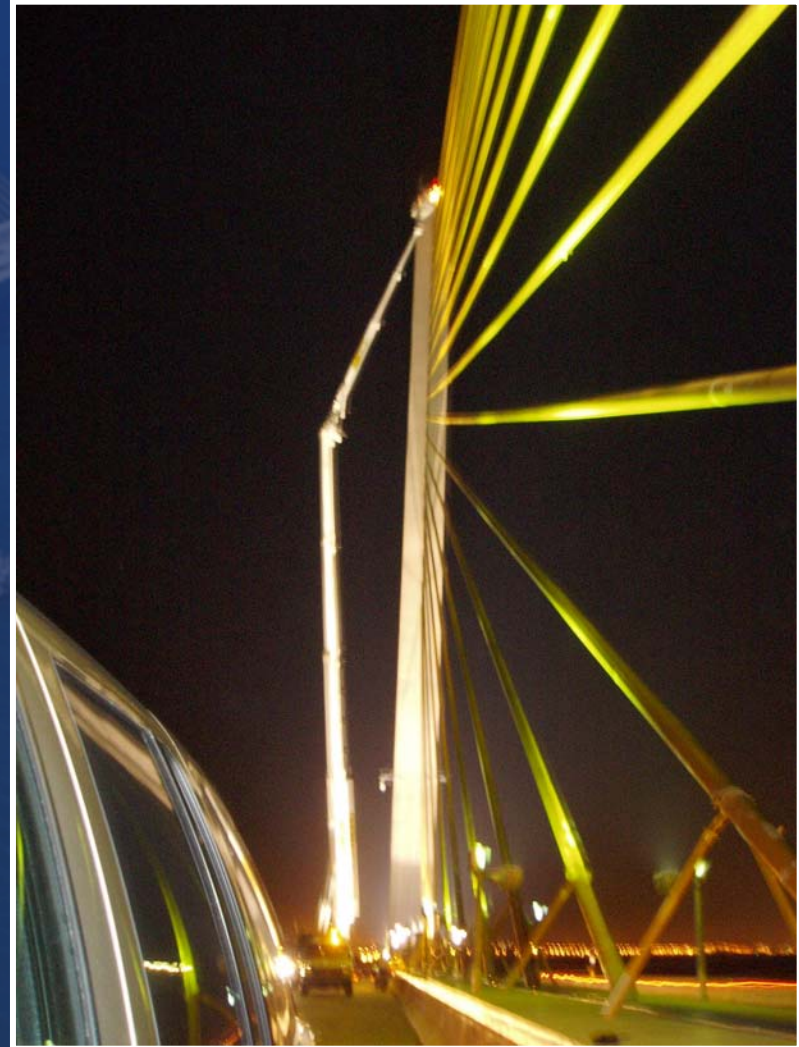
*Routine Bridge Inspection*
